# Risk Alert

## RA74 - Containerised Cargo – Stowage and Securing

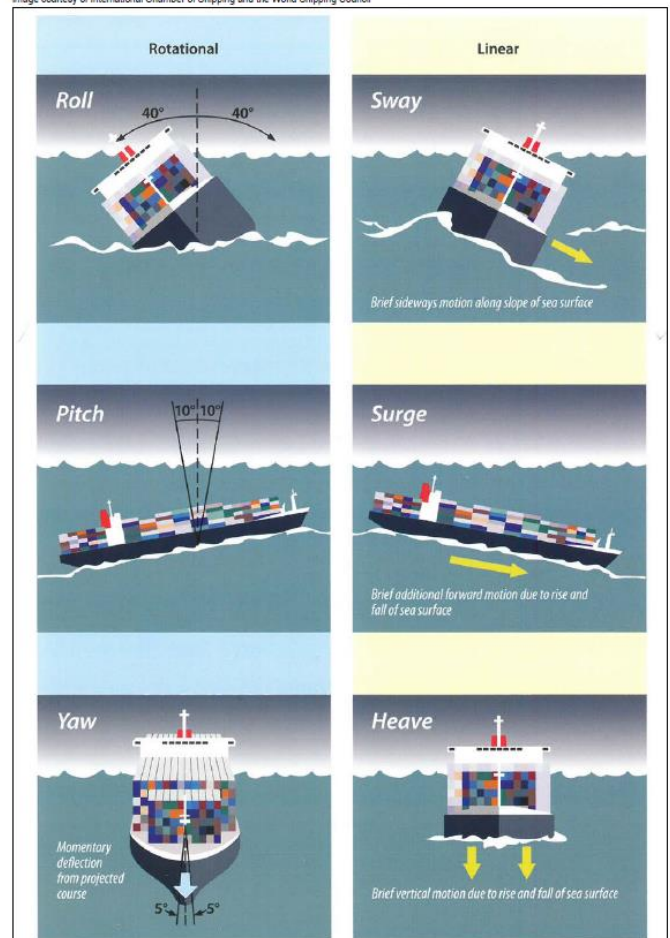
**Ships motions in heavy seas – [MAIB report no 2/2020](#)**

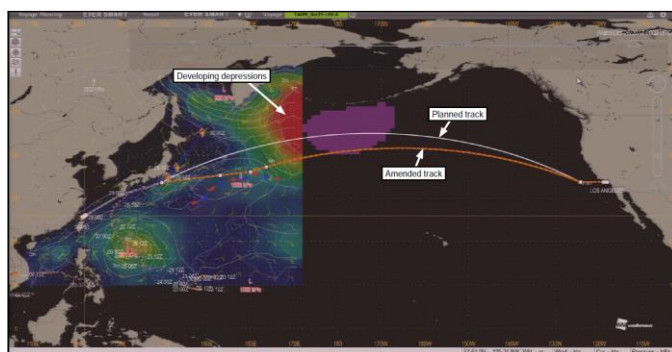
Vessel's Track (local time): Ref: [MAIB report no 14/2020](#)

Master had changed the ship's passage plan to avoid severe weather caused by a developing depression east of Japan. The ship continued in heavy seas; **rolling and pitching heavily with frequent bow flare slamming.**

and toppled to port. Of the 151 containers in the stow, 42 were lost overboard and 34 were damaged. Superficial damage was caused to the ship.

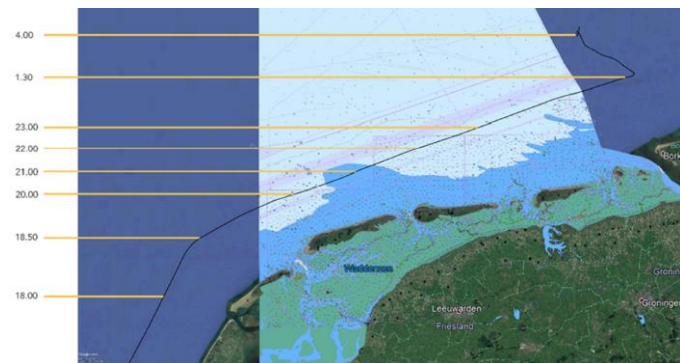
around 1800 hours. At 1850h as the vessel changed course to starboard to enter the southern track of the Terschelling - German Bight TSS the wind increased to force 9 Bft. Vessel was on manual steering and rolling between 5 and 10°, with occasional 15° peaks. At 2300h, the vessel suddenly started to roll violently (20° - 30°), for around 30 seconds. These violent movements caused equipment to shift in the fitness area and on the bridge. The vessel returned to the previous 5 to 10° roll soon after, the speed at the time was 8 - 10 kn.

Track of MSC ZOE (time indication local time): Ref: [Joint investigation report - MSC Zoe 01 - 02 Jan 2019](#)

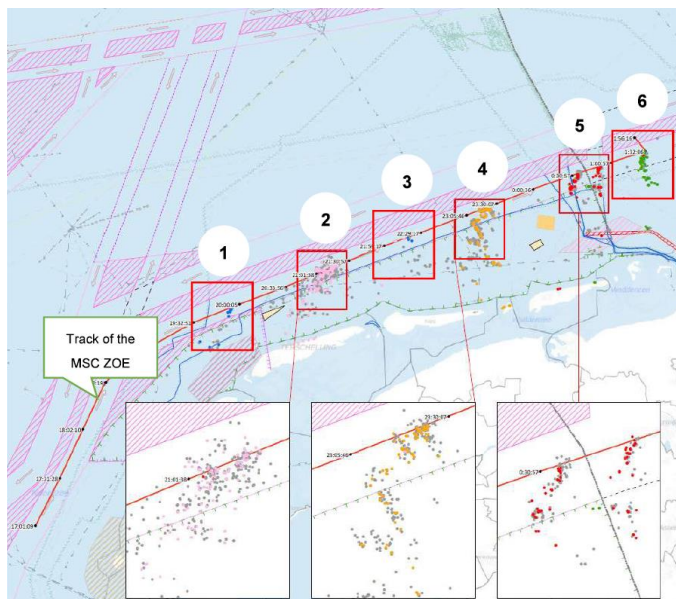
- Impact on the Dutch and German coasts, marine life and environment attracted considerable public concern in the Netherlands and in Germany.
- Debris sank or washed ashore as the fall from height and the waves destroyed most of the containers.
- Seabed survey identified more than six thousand objects.

Six main recovery locations of lost containers. Ref: [Joint investigation report - MSC Zoe 01 - 02 Jan 2019](#)
