The Bahamas
Maritime Authority

“M.V Bulk Jupiter”

Report of the marine safety investigation into the loss of a bulk carrier in the South China Sea on January 2nd 2015

Date of Issue: 18th August 2015

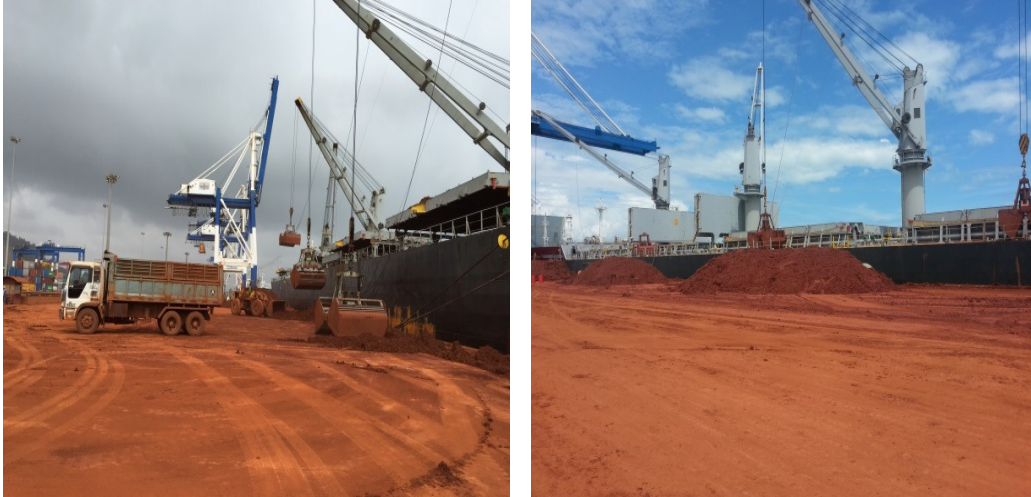
- 2.4.8 Bauxite is loaded at the multipurpose berths in Kuantan using vessels' own cargo gear (Figure 5). Bauxite is usually loaded on to road trucks and carried to loading berths from in-port area stock piles, storage facilities near the port or directly from the mines.

Figure 5: Loading with vessel's cranes and grabs

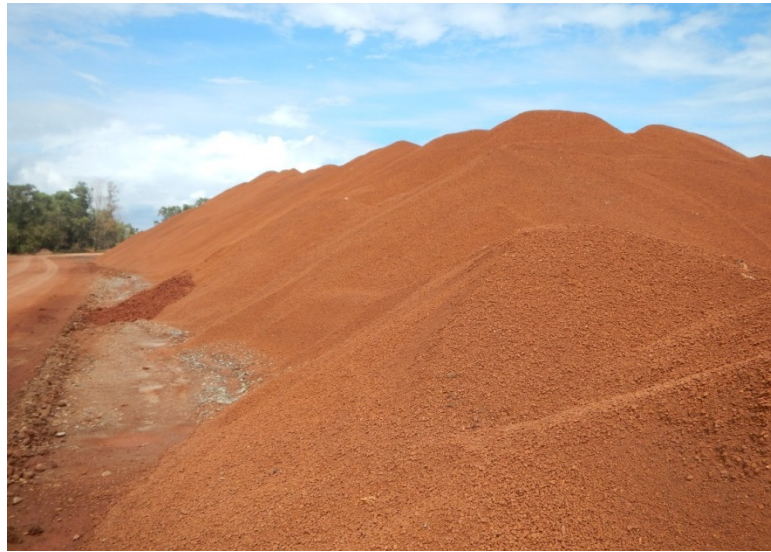
Figure 8: Open storage of processed Bauxite

2.5.5 There are a number of mines dotted around Kuantan Port with varying sizes of operations. Some mines simply excavate bauxite and transport the product via trucks while other, typically larger, mines both excavate and process the mineral. In either case, there is no covered storage facility that affords any protection from the rain or surface water runoff. Occasionally protection was provided to the bauxite when it was transported by truck from outside the port; it was covered by a tarpaulin (Figure 9).

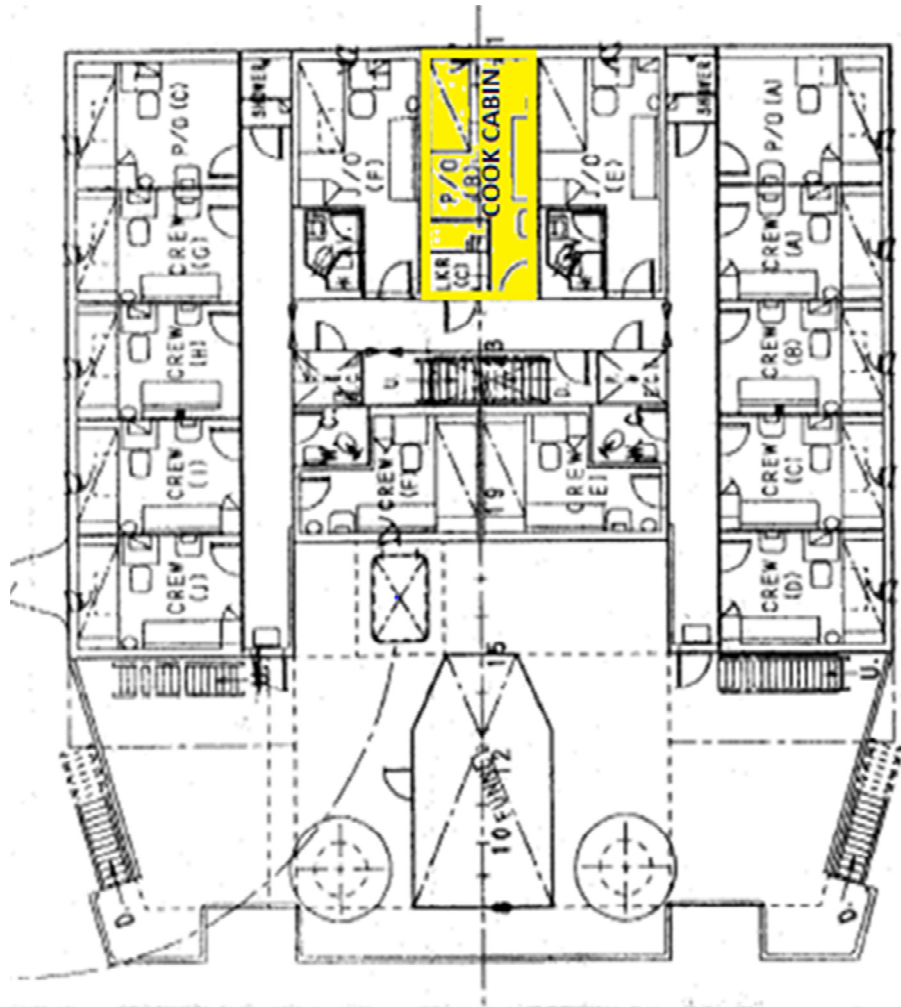
recollection the weather was starting to deteriorate as the vessel was rolling more heavily than the previous day. With the galley setup he then returned to his cabin (see figure 15) on 'B' deck.

Figure 15: Chief Cook's cabin (highlighted), 'B' Deck

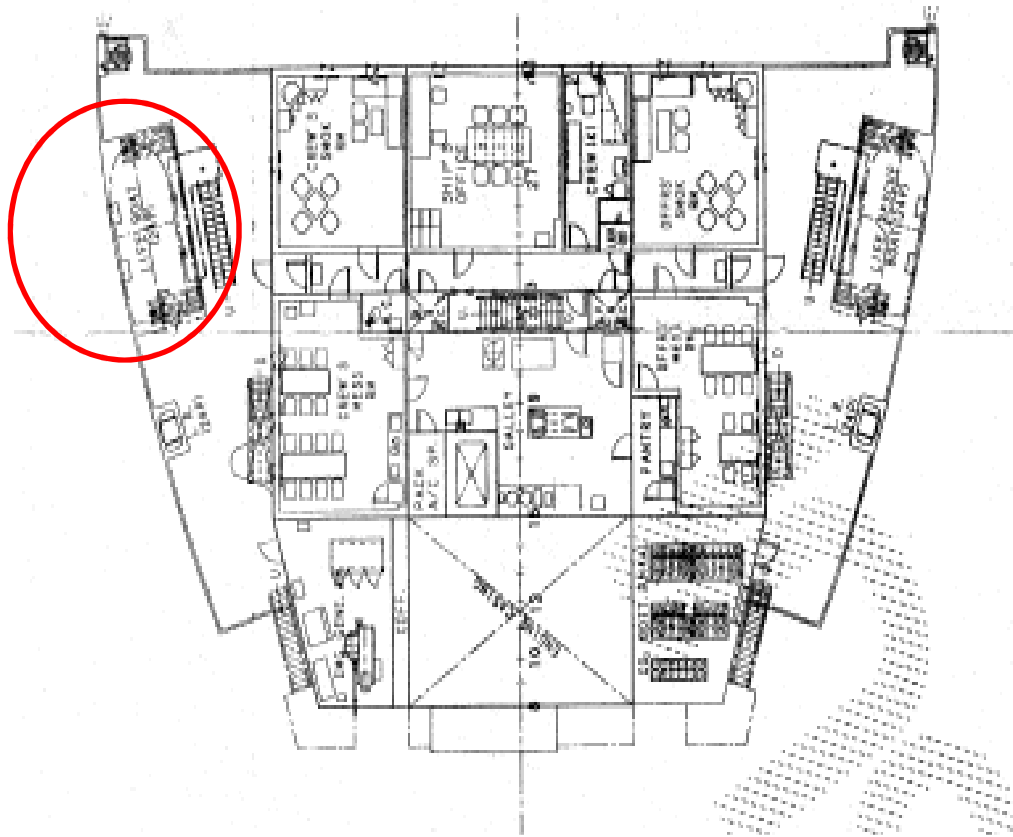
Figure 16: 'A' Deck, port and starboard lifeboat access (port highlighted)

- 3.23 Due to the angle of list the Chief Cook was unable to make his way to the port side access door, at which point he made the decision to utilize the internal staircase and proceed up to 'C' deck where he met the Master. He instructed the Chief Cook to follow him and together they exited the accommodation block via the starboard side access door (see figure 17). No other crew were seen on board by the Chief Cook after this point in time.

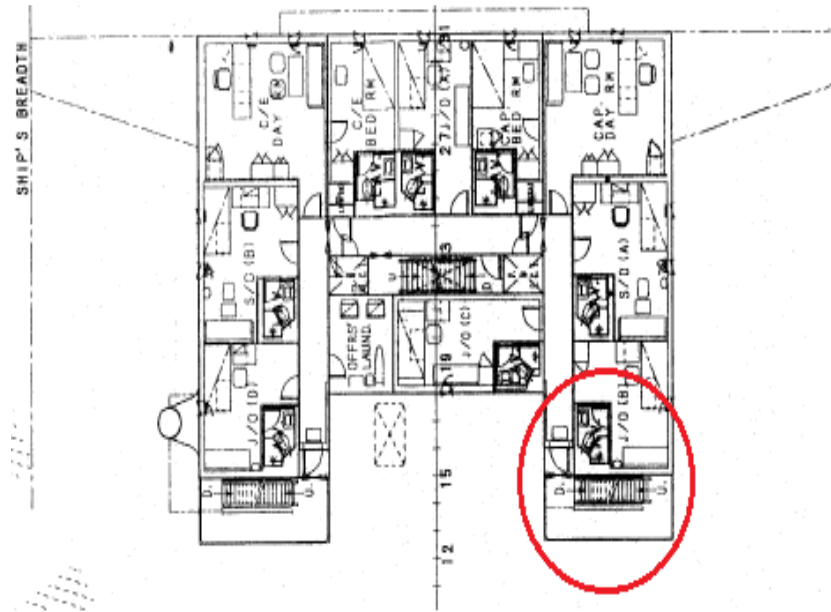
Figure 17: 'C' Deck, starboard aft, external stairway (highlighted)

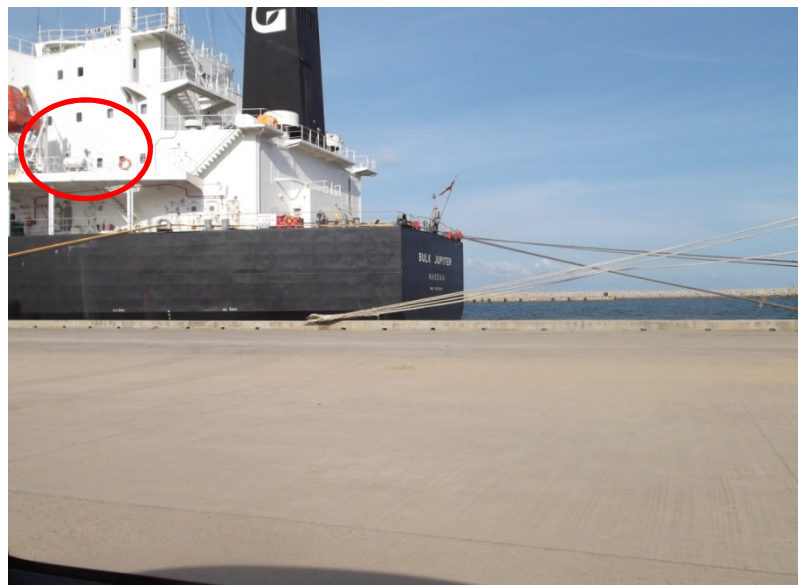
- 3.24 Having exited the accommodation area of the vessel both men found themselves on a small platform (see figure 18), on the starboard side, aft external stairway with the waves washing over them. The Master, wearing his lifejacket, jumped into the sea followed shortly after by the Chief Cook who at this point had donned his lifejacket - neither were wearing an immersion suit. The Chief Cook confirmed that he did see a life raft in the sea but was unable to reach it; he did notice that no one was present inside. The two men stayed together while swimming away from the vessel prior to it sinking. As they looked back from a safe distance, despite the heavy seas they could just see that the vessel had almost disappeared beneath the waves.

Figure 18: 'C' Deck, port aft, external platform (highlighted) similar to that of the starboard platform

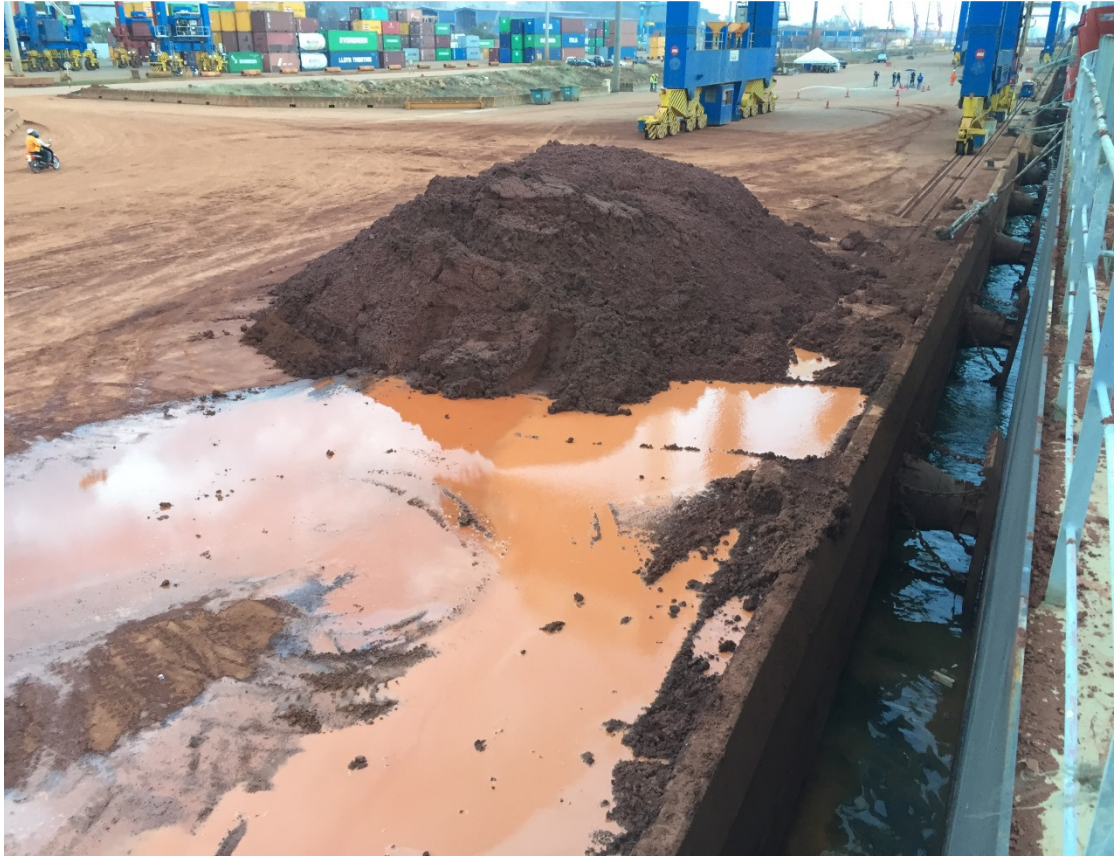
Figure 35: 'm.v Medi Okinawa' alongside container berth, Kuantan, embarking Bauxite
