SAFETY INVESTIGATION REPORT

REPORT NO.: 05/2016

April 2016

MV POLYNESIA **Fatal fall overboard during** **cargo operations at** **Pago Pago, American Samoa** **02 April 2015**

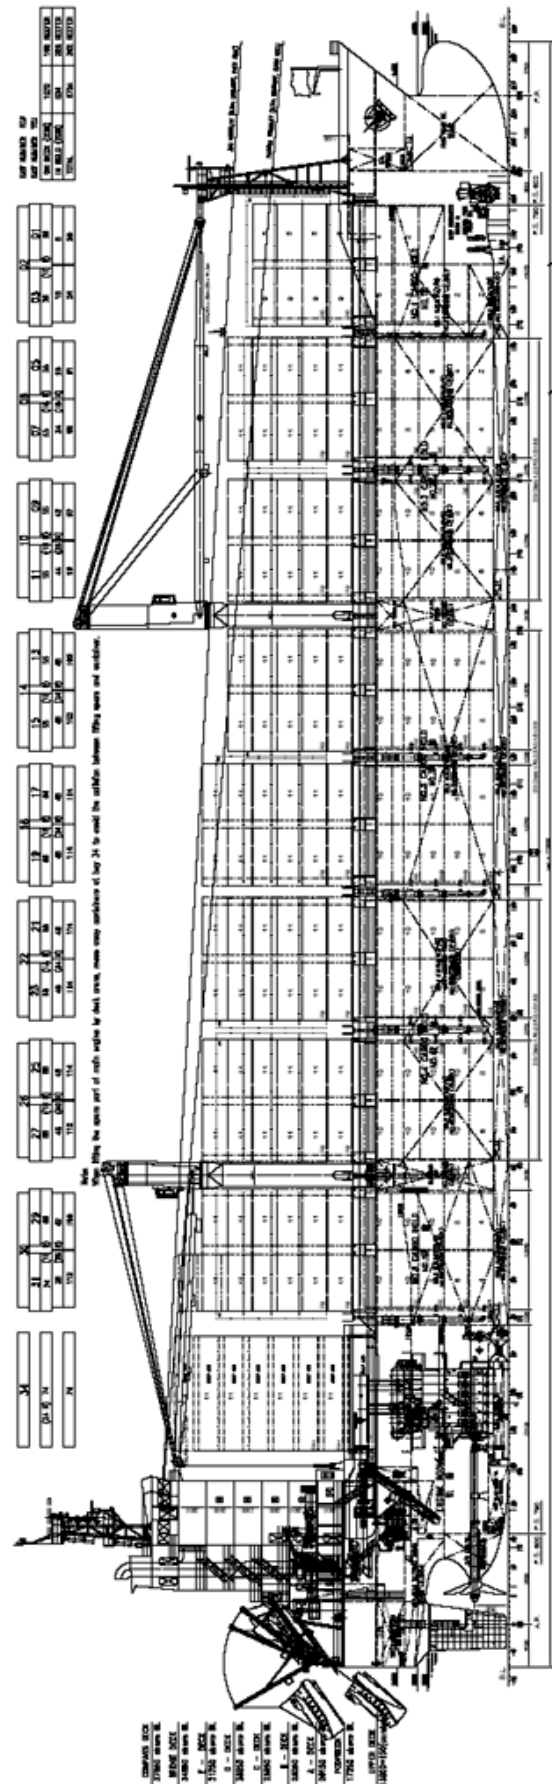
Figure 1: *Polynesia* GA Plan

Polynesia (Figure 1) has a length overall of 171.93 m, a moulded breadth of 27.40 m and a moulded depth of 13.80 m. She has a summer draught of 9.50 m and a corresponding deadweight of 27010 tonnes.

Polynesia has five cargo holds and eight hatches, which are all fitted forward of the accommodation block. Two cargo deck cranes are fitted, each with a SWL of 45 tonnes. *Polynesia* has a capacity of 1704 TEUs, of which, 634 could be loaded in the cargo holds. The deck had a capacity of 1070 TEUs.

The height from the baseline to the top of the cargo hatch cover measured approximately 16.60 m. The mean draft was approximately 8.35 m. Therefore, the height of the cargo hatch cover from the water line at the time of the accident was approximately 8.25 m.
