MARINE ACCIDENT
INVESTIGATION BRANCH

SAFETY DIGEST

**Lessons from Marine
Accident Reports
2/2015**

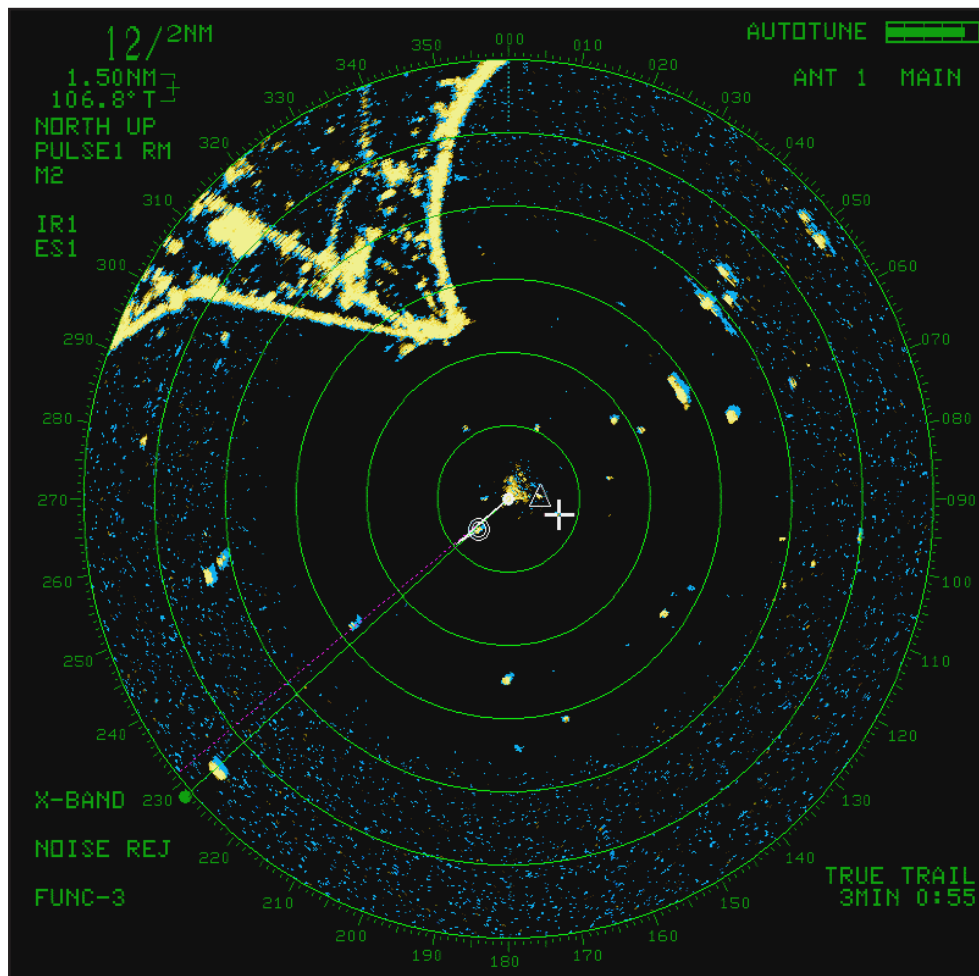
Figure 3: General cargo vessel - ARPA radar display at 1007

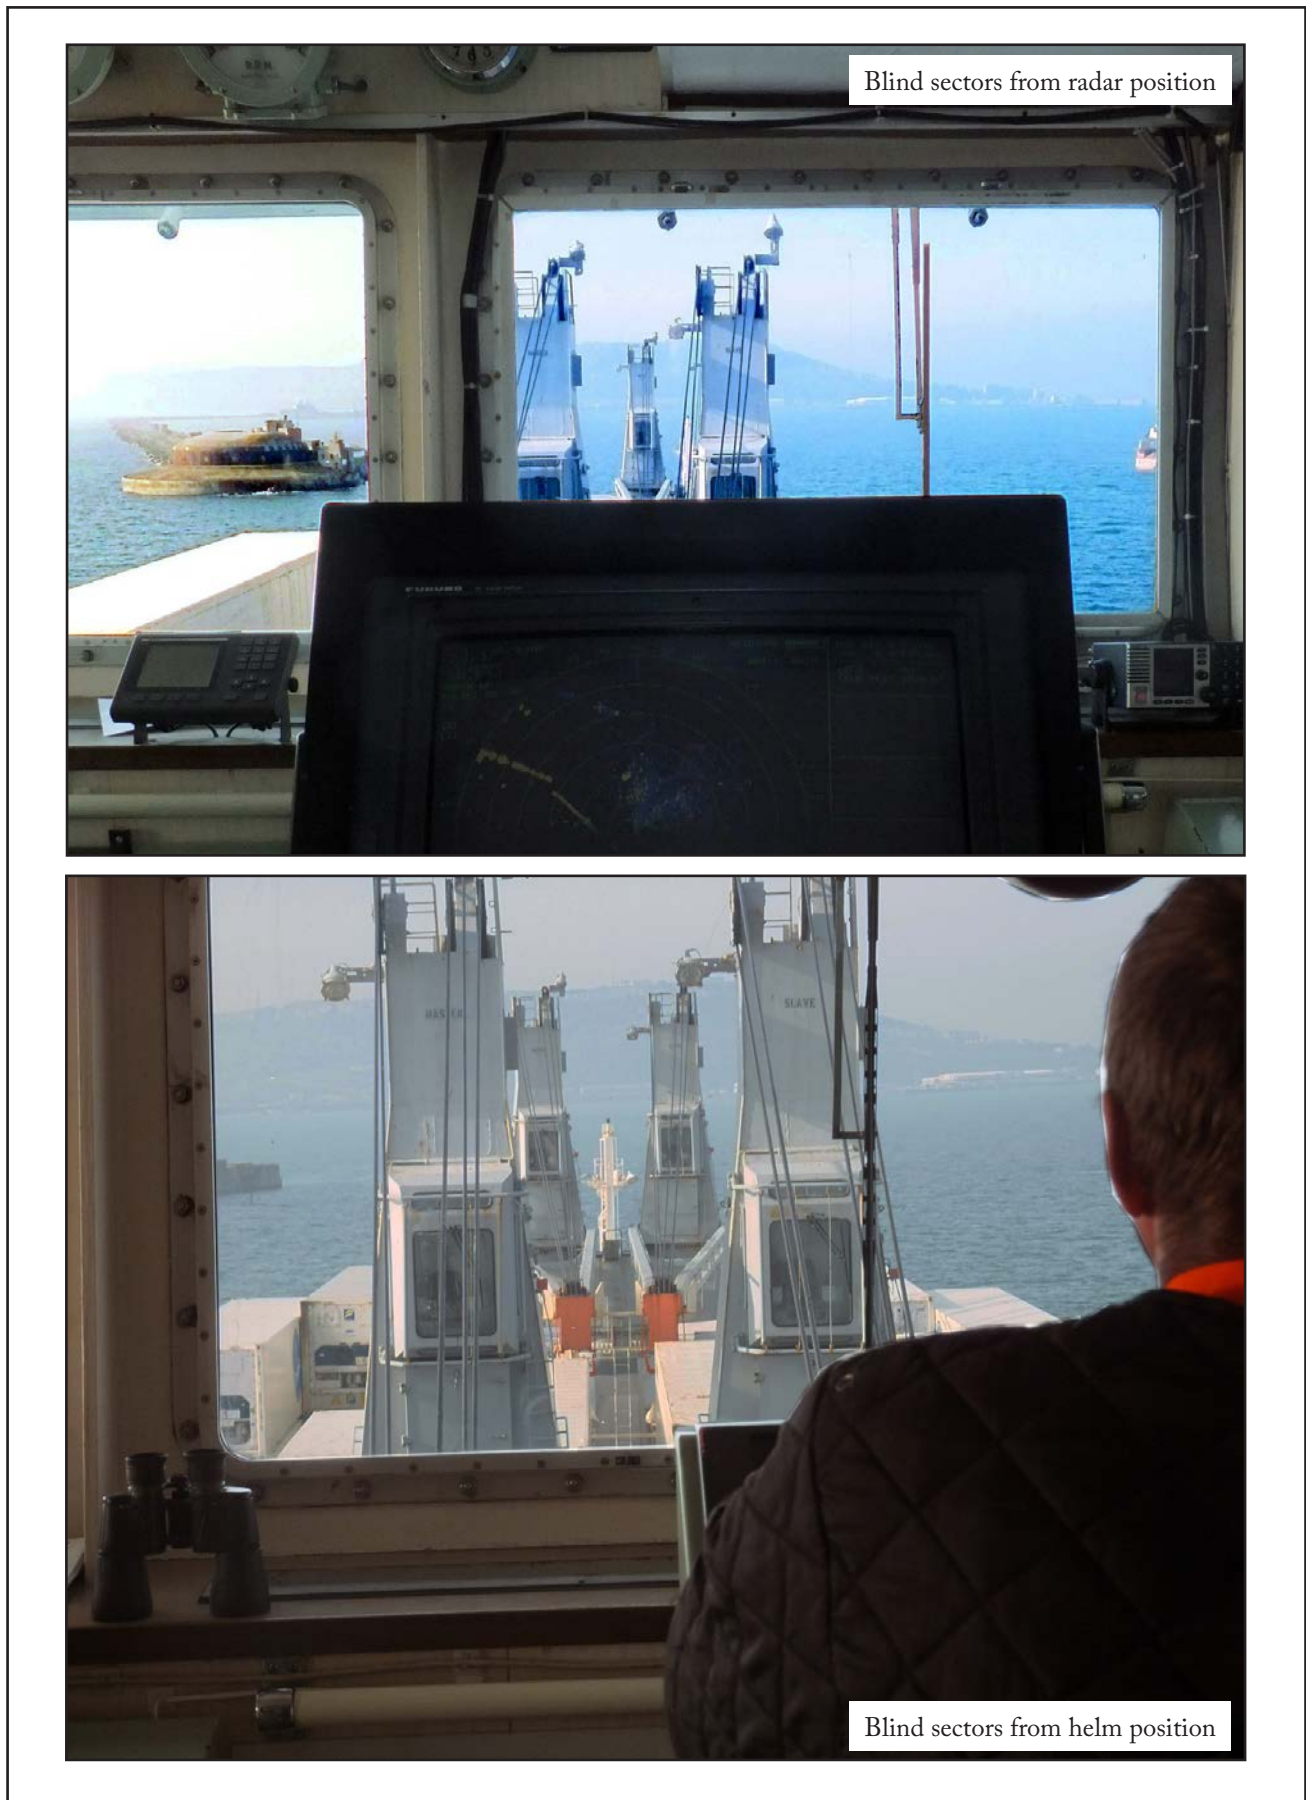
4. By failing to move around the bridge periodically, the master of the cargo vessel did not see the tanker visually until it was too late to avoid collision because of blind sectors ahead created by deck cranes. Always move around the bridge when keeping watch to ensure that target vessels are not hidden in blind sectors. Moving around the bridge will also keep you stimulated and alert!

Figure 4: General cargo vessel bridge showing blind sectors from radar and helm positions

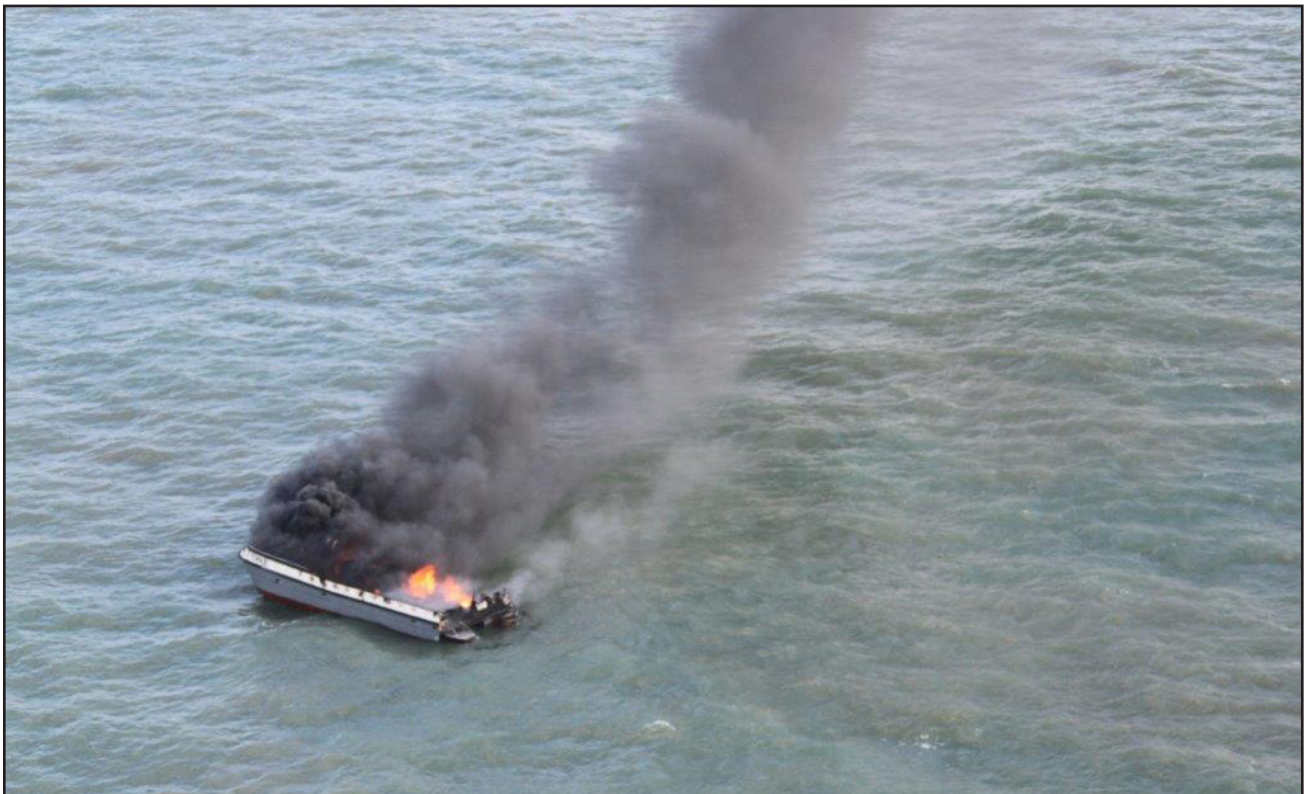
The crew were unable to extinguish the fire, and abandoned to a liferaft from where they were subsequently airlifted to safety. Shortly afterwards, the burnt out wreck of the vessel

Figure 1: Burning workboat before it sank

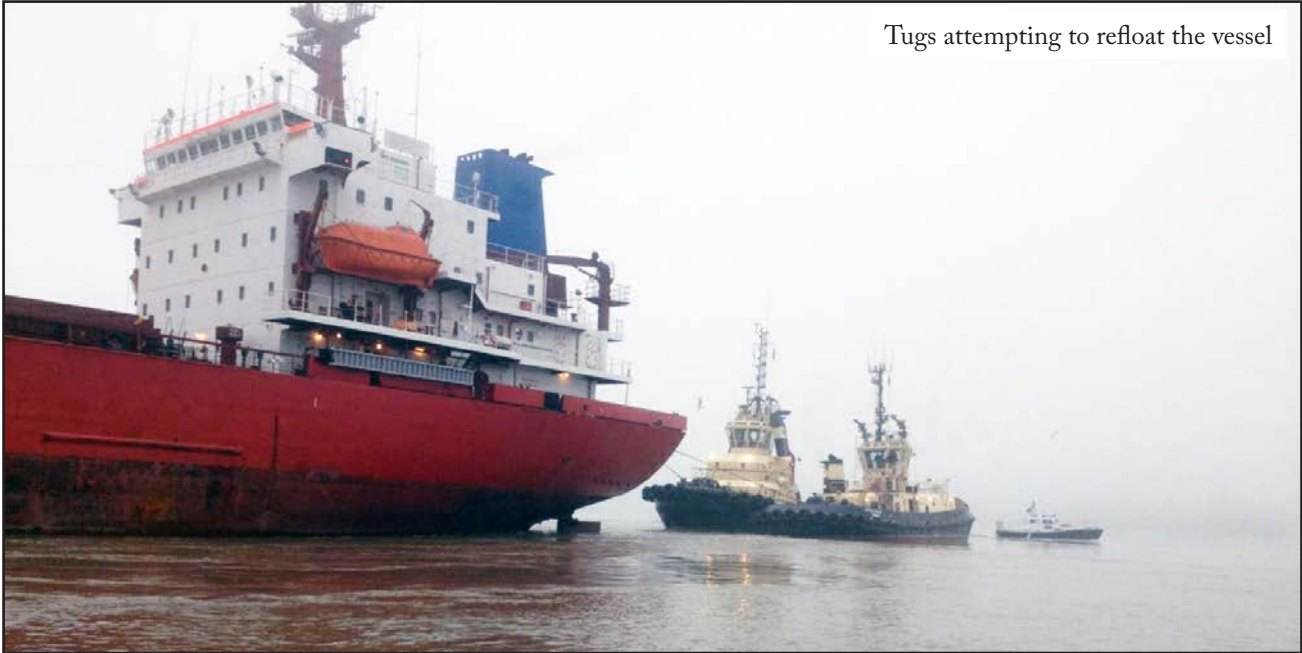
As a result of the contact the vessel was holed above the waterline, but no damage was caused to the hull by the grounding, which occurred in an area of soft mud. The vessel was refloated

Tugs attempting to refloat the vessel

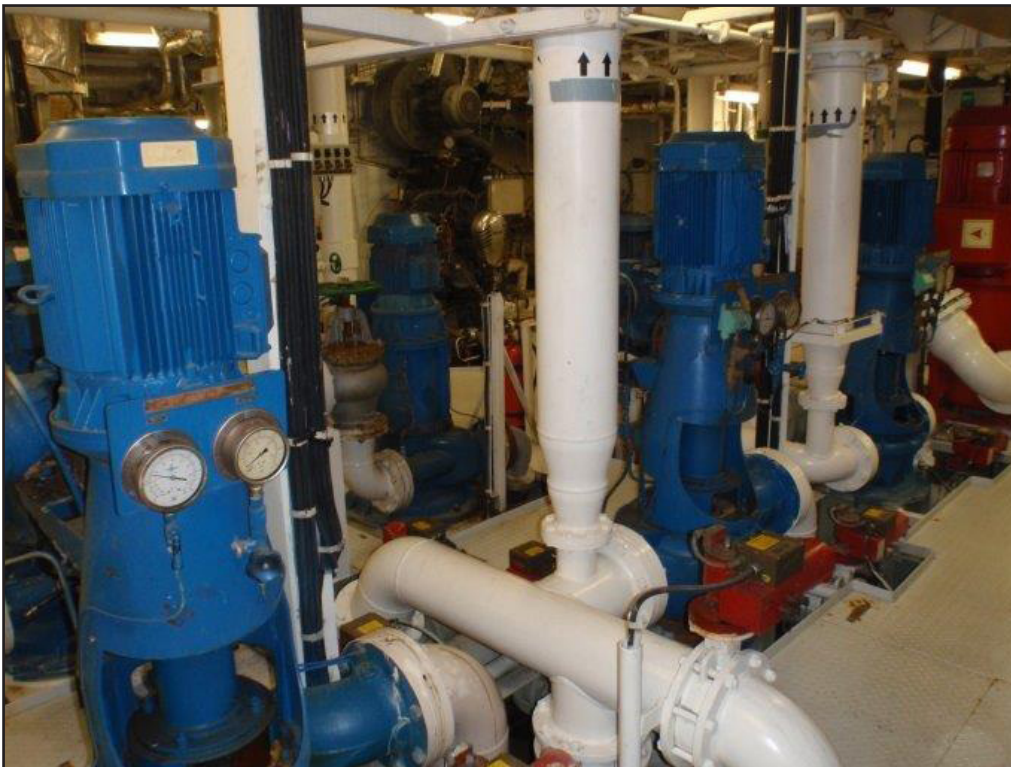
To configure the ballast system, the second officer accessed the ballast system screen on the PMS. This showed all the ballast pumps and ballast valves, but it did not show the cross-over valve connecting the ballast system with the bilge system. This valve was only shown on the bilge system screen, which was not selected for viewing. Using the PMS, the second officer opened the required ballast system valves and started a ballast pump. The transfer of ballast water commenced.

Figure 1: Bilge and ballast pumps and valves

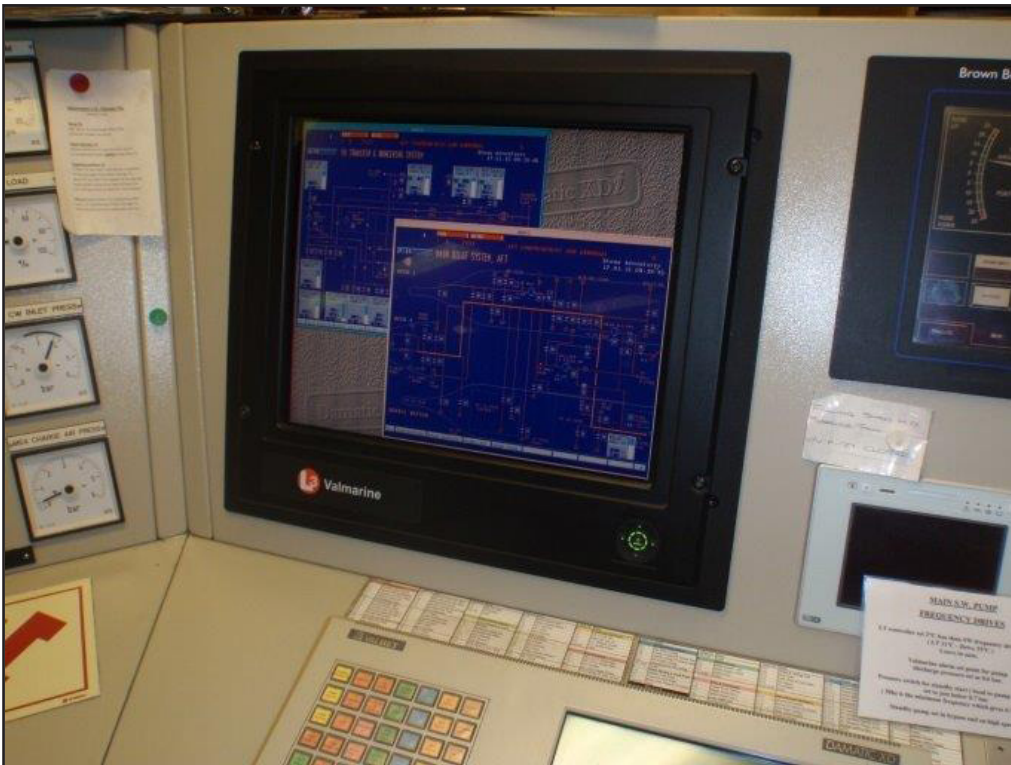
Figure 2:
PMS control station

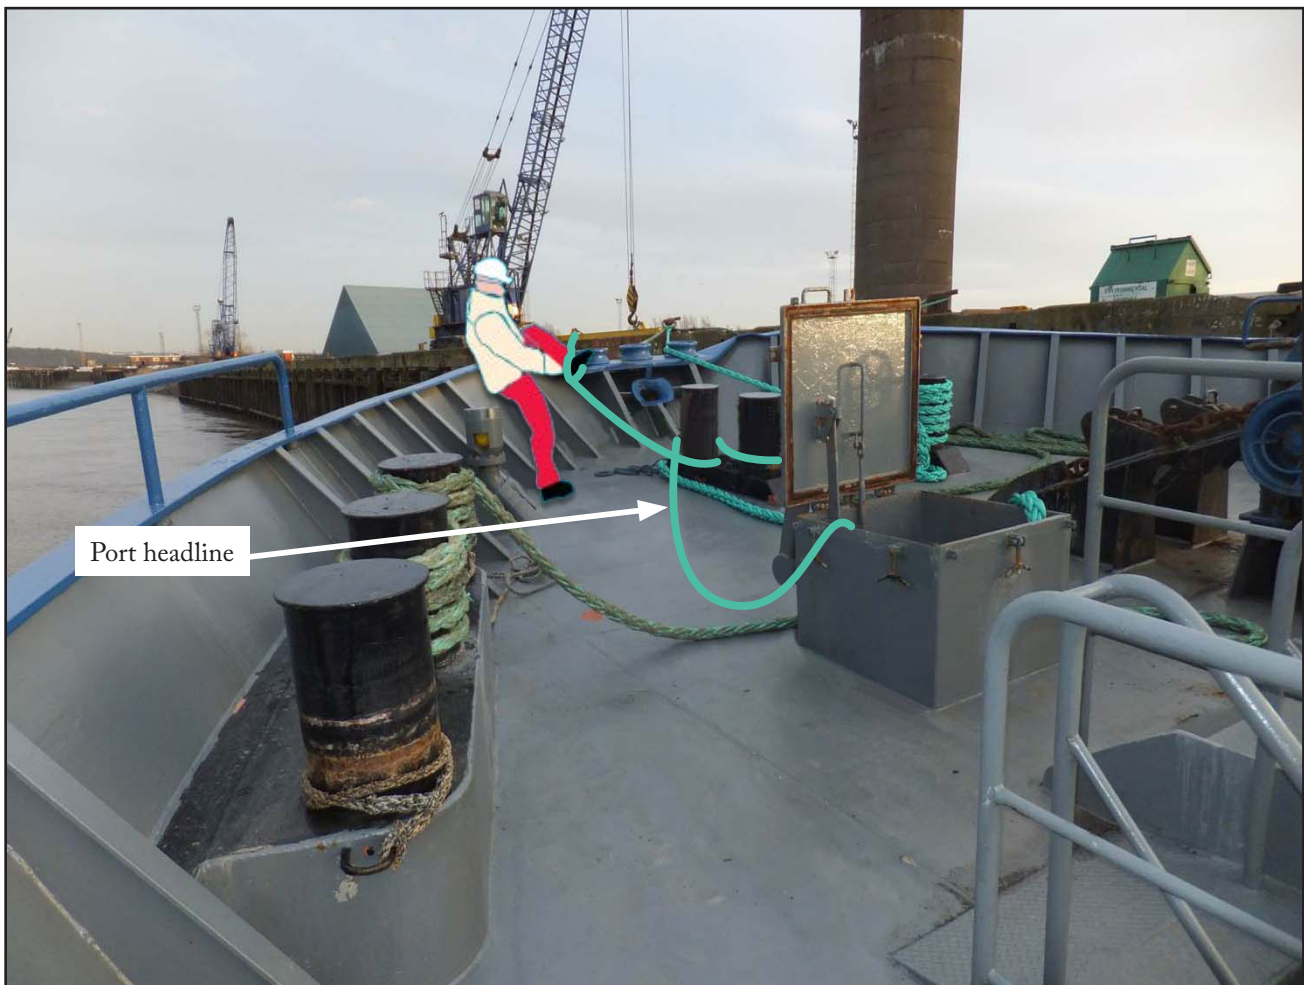
2. The crewman was unsupervised at the time of the accident and it is probable that his foot became trapped in a bight when he was controlling the slack rope with his foot as the headline paid out. Mooring operations should always be supervised by a competent person who can retain an effective overview of the operation, to ensure that appropriate safety standards are maintained.

Reconstruction of accident scenario

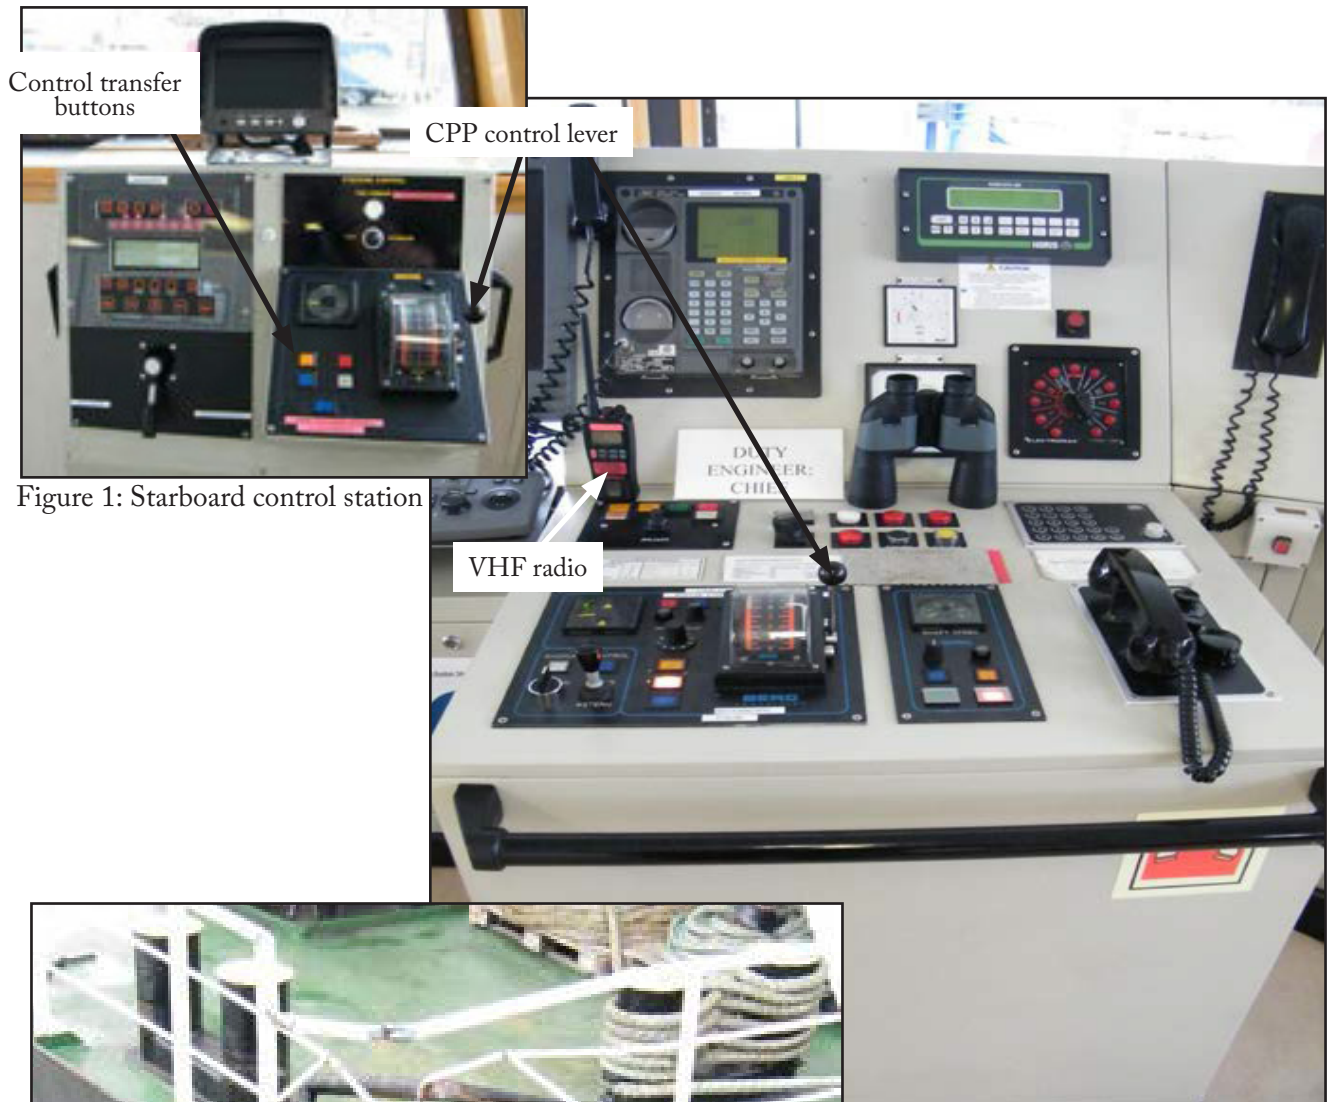
Figure 1: Starboard control station

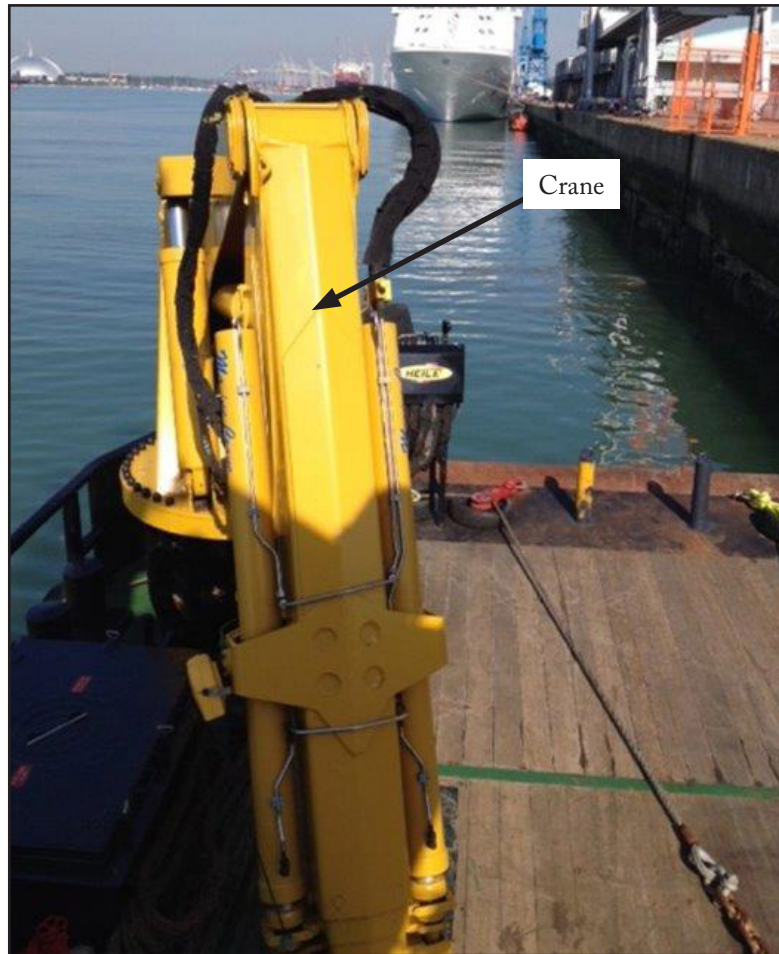
Figure 1: View forward

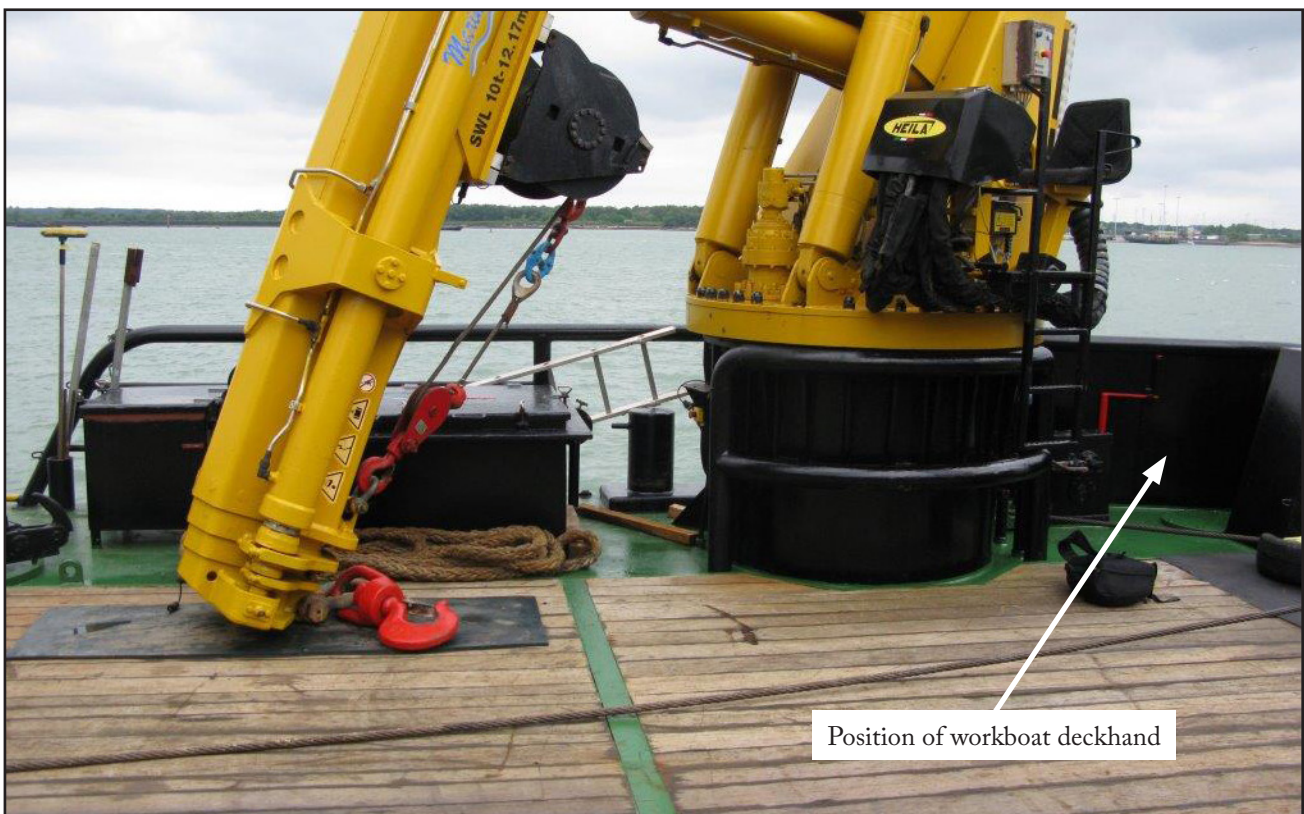
Figure 2: View towards port side

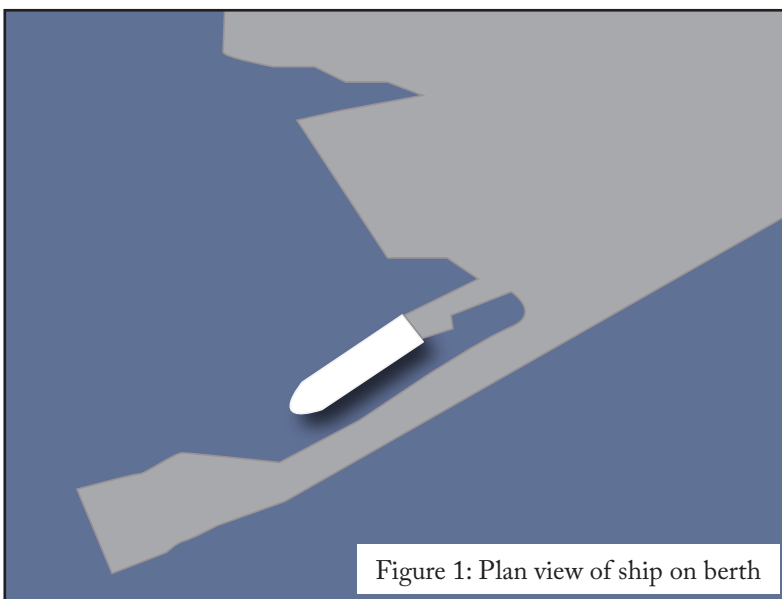
Figure 1: Plan view of ship on berth

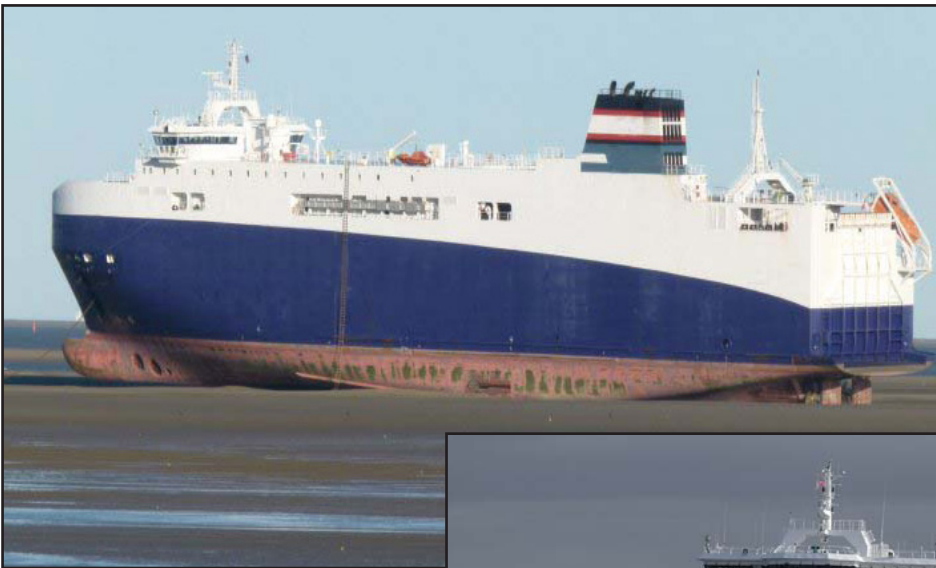
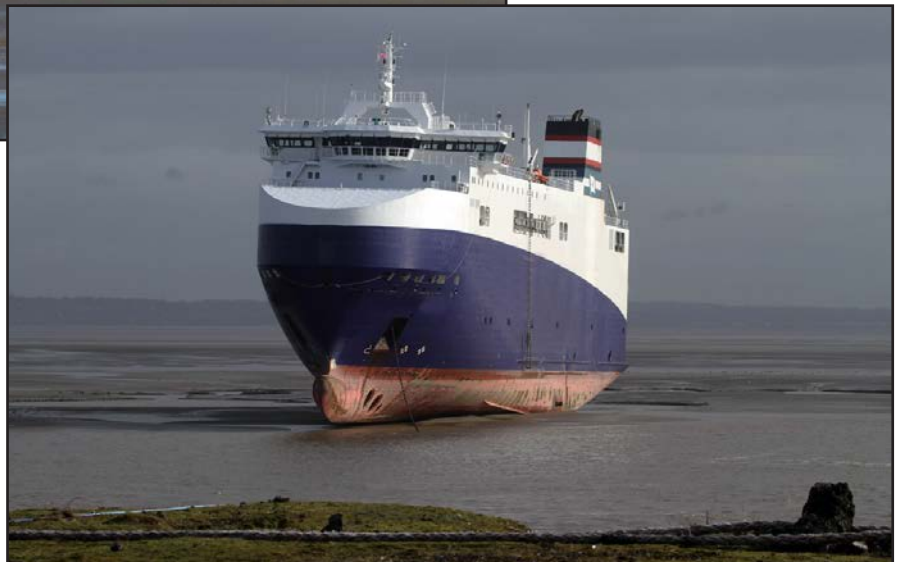
As the vessel was blown out of the dredged area of the port towards shallow water, a port pilot embarked to assist the master and they agreed that, due to the high winds, it was no longer possible to sail into open water. The master, helped by the pilot, spent the next 50 minutes trying to reduce the vessel's exposure to the wind and to keep the vessel in deep water. However, the vessel ultimately grounded on sand and mud 45 minutes after high tide (Figures 2a and b).

Figures 2a and b: Vessel aground

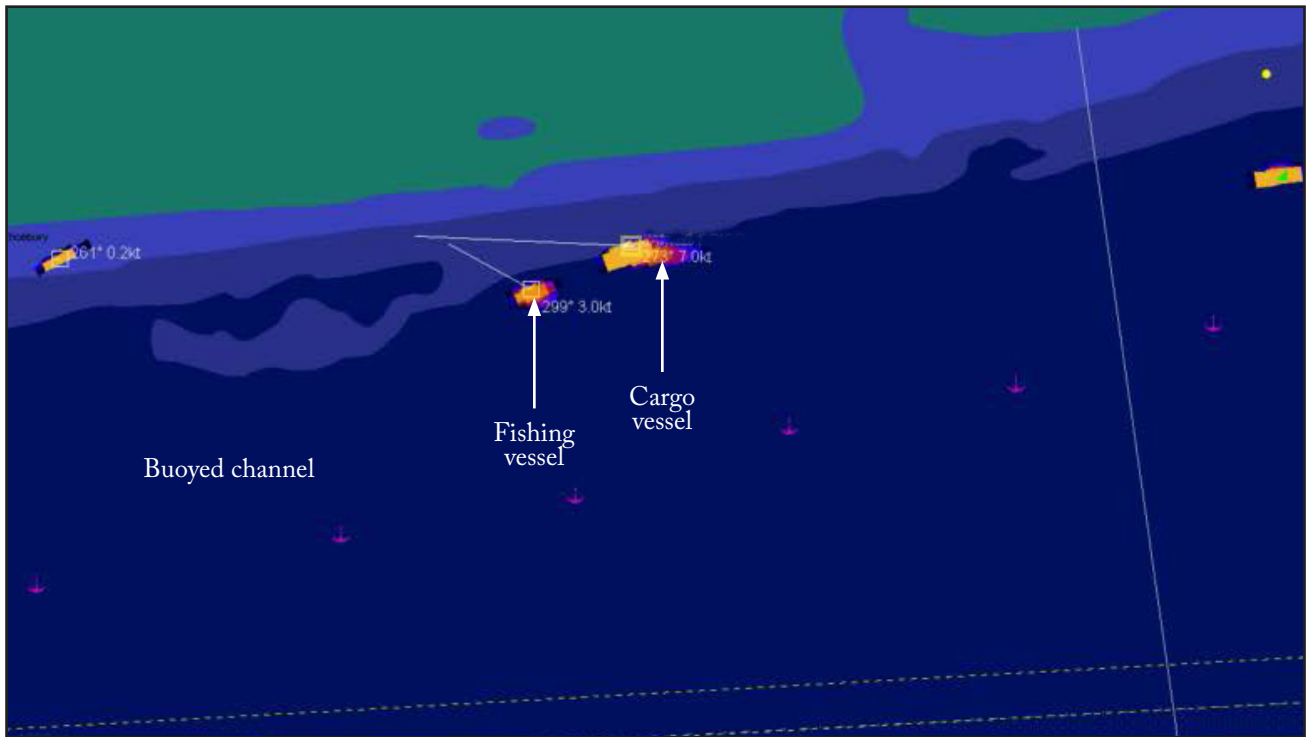
Figure 3: Snapshot 3

The cargo ship was only 0.2nm away and the vessels were now heading for a collision (Figure 3). In response, the cargo ship's deckhand turned the cargo ship further to the north, reduced its speed and sounded the general alarm. However, the vessels collided soon after (Figure 4); the trawler's bow struck the cargo ship's port side. The cargo ship then ran aground in shallow water outside the channel.

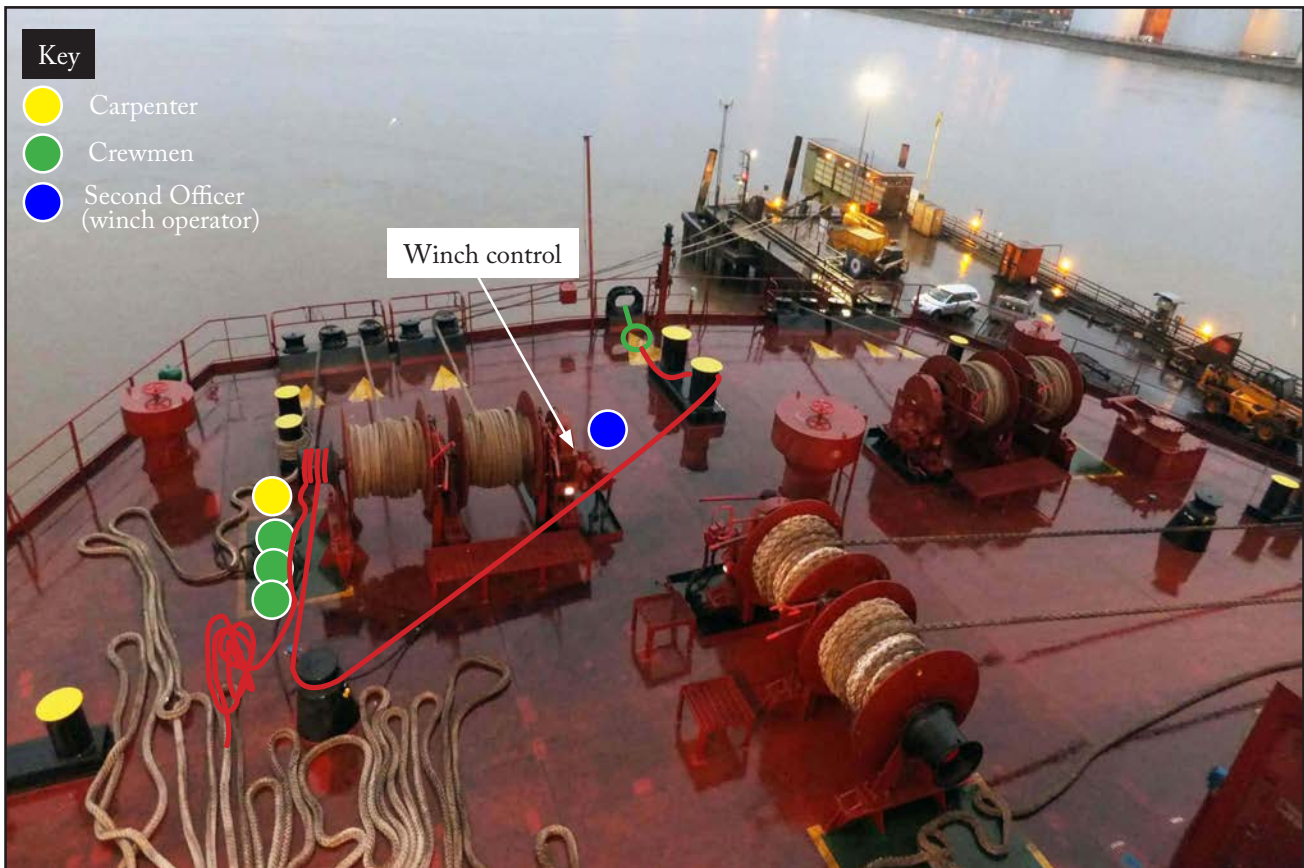
It was established that a section of the tensioned messenger line slipped off the end of the warping drum and struck the carpenter on his neck.

Layout of mooring equipment and messenger line routing at the time of the accident

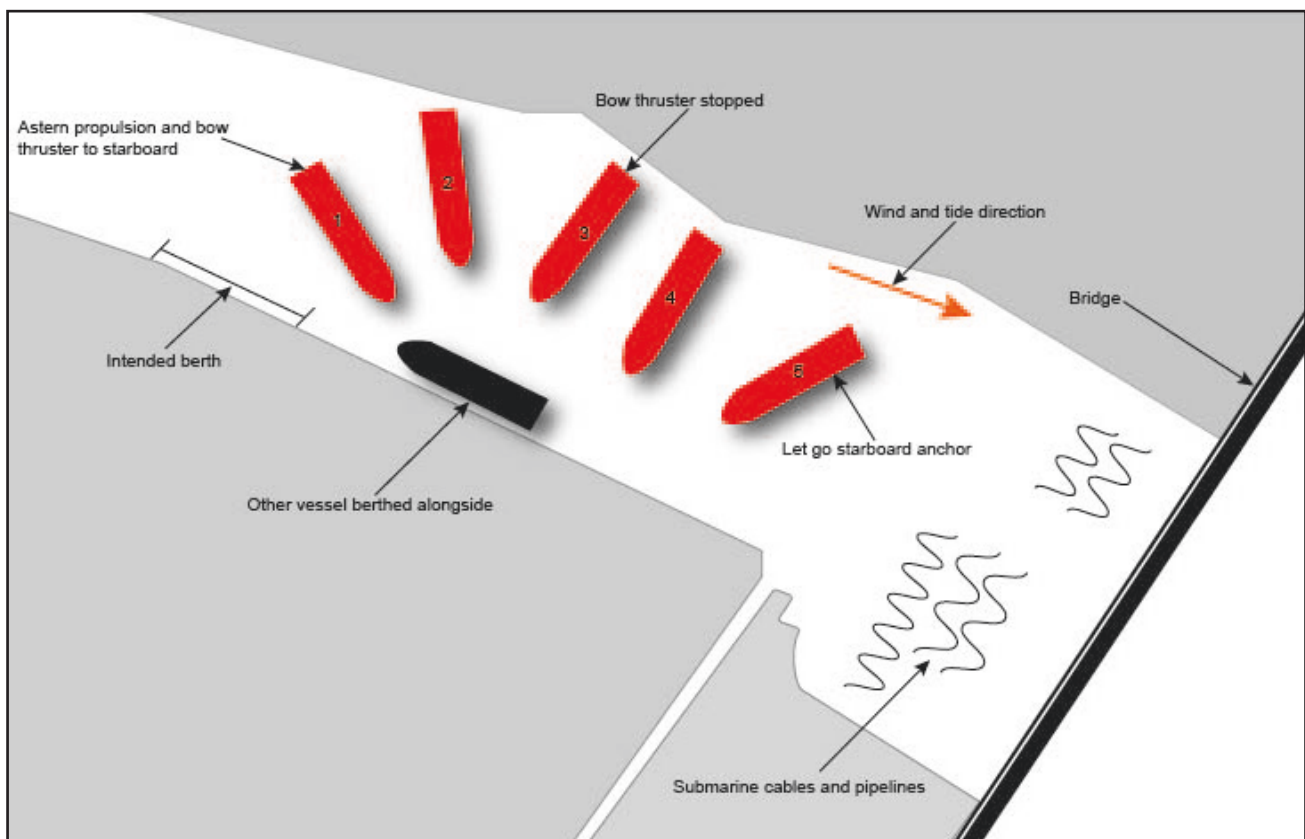
The pilot ordered astern propulsion and bow thruster to starboard. Halfway into the turn, the bow thruster stopped. Aware that the vessel was being set towards a bridge that spanned the waterway, and that he would be unable to complete the turn using only helm and propulsion, the pilot ordered the starboard anchor, and then the port anchor, to be let go. Although this had the effect of assisting the turn, the vessel was too close to the bridge to prevent its stern impacting with it.

Sequence of events leading up to the accident

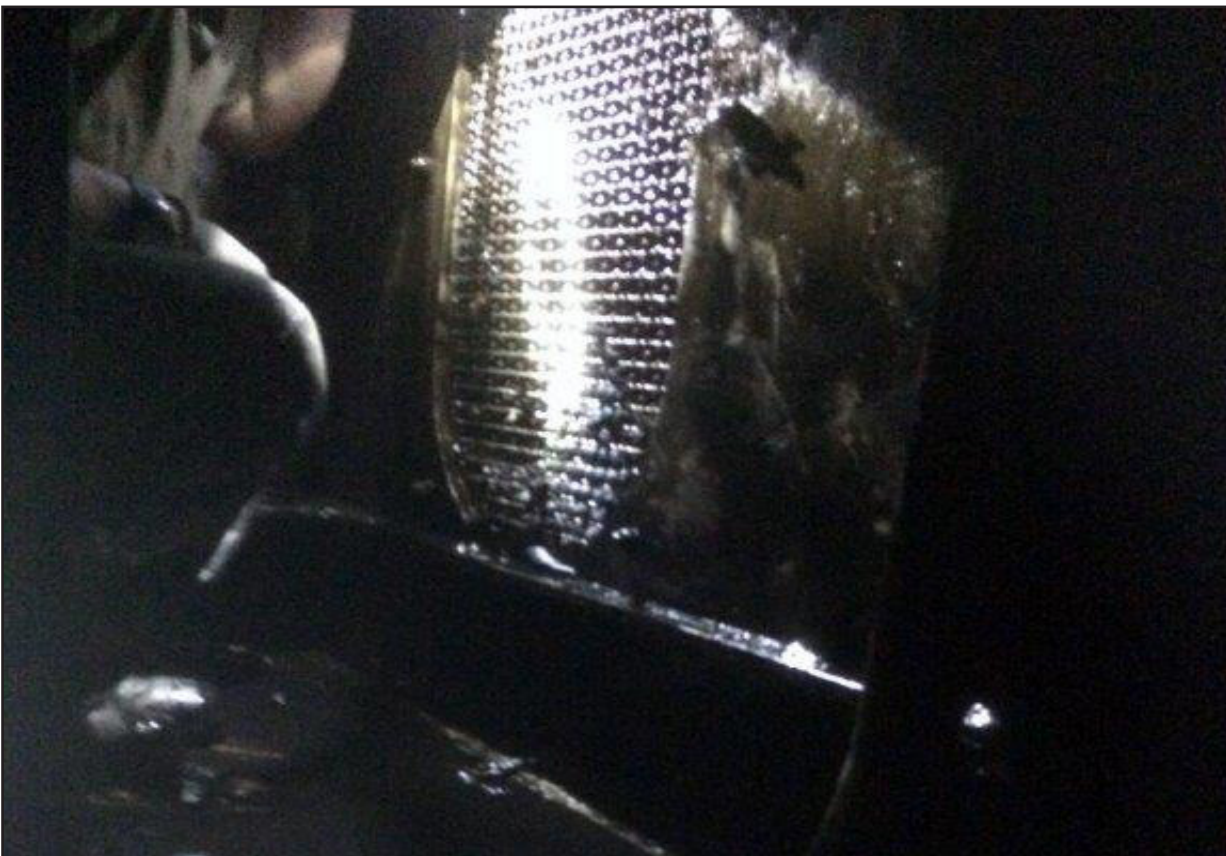
Figure 2: Sump grid

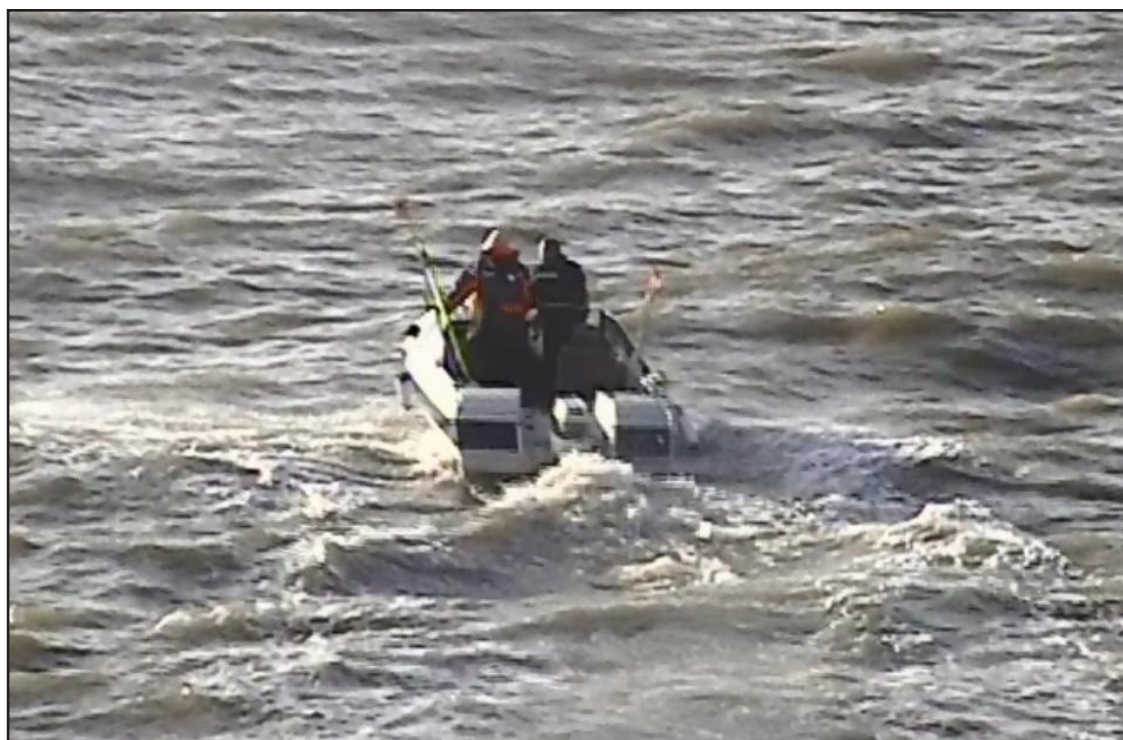
Figure 1: The men leaving harbour

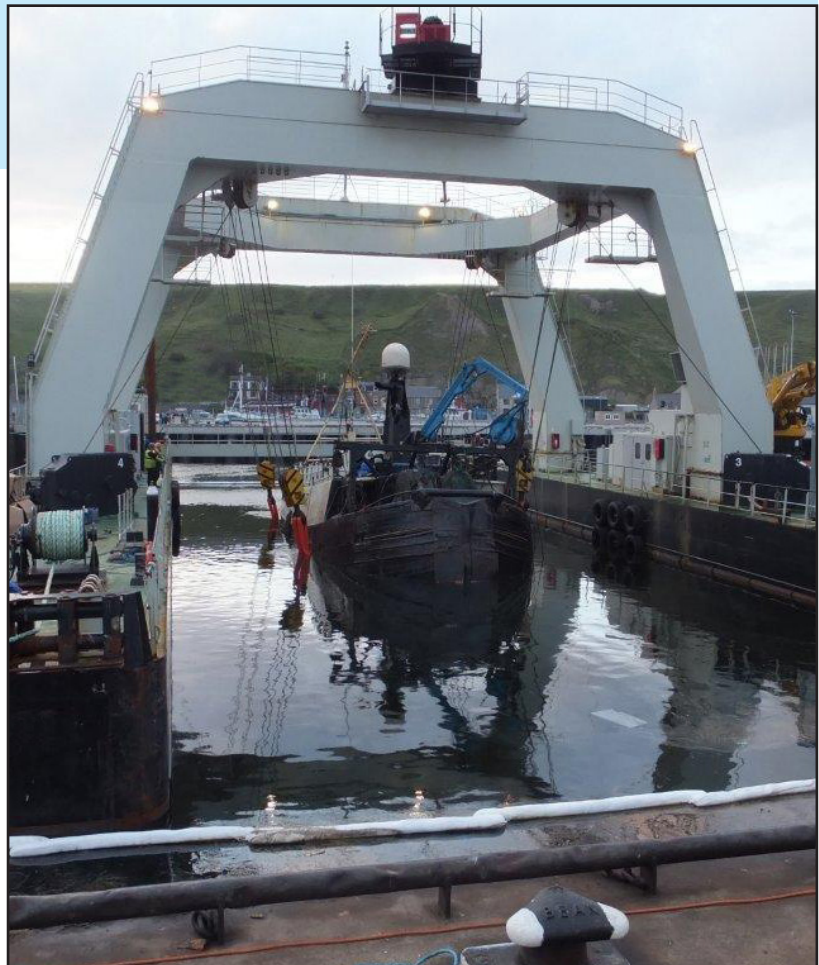
The trawler was eventually re-floated (Figure 2) and an investigation discovered that the loss of control was due to a clamp, used to secure the Morse cable between the control lever in the wheelhouse and the engine and gearbox, detaching from supporting framework (Figure 3). The clamp had been secured with one rather than two screws as intended (Figure 3 inset) and the lone screw had worked loose and had fallen out.

Figure 2: Salvage

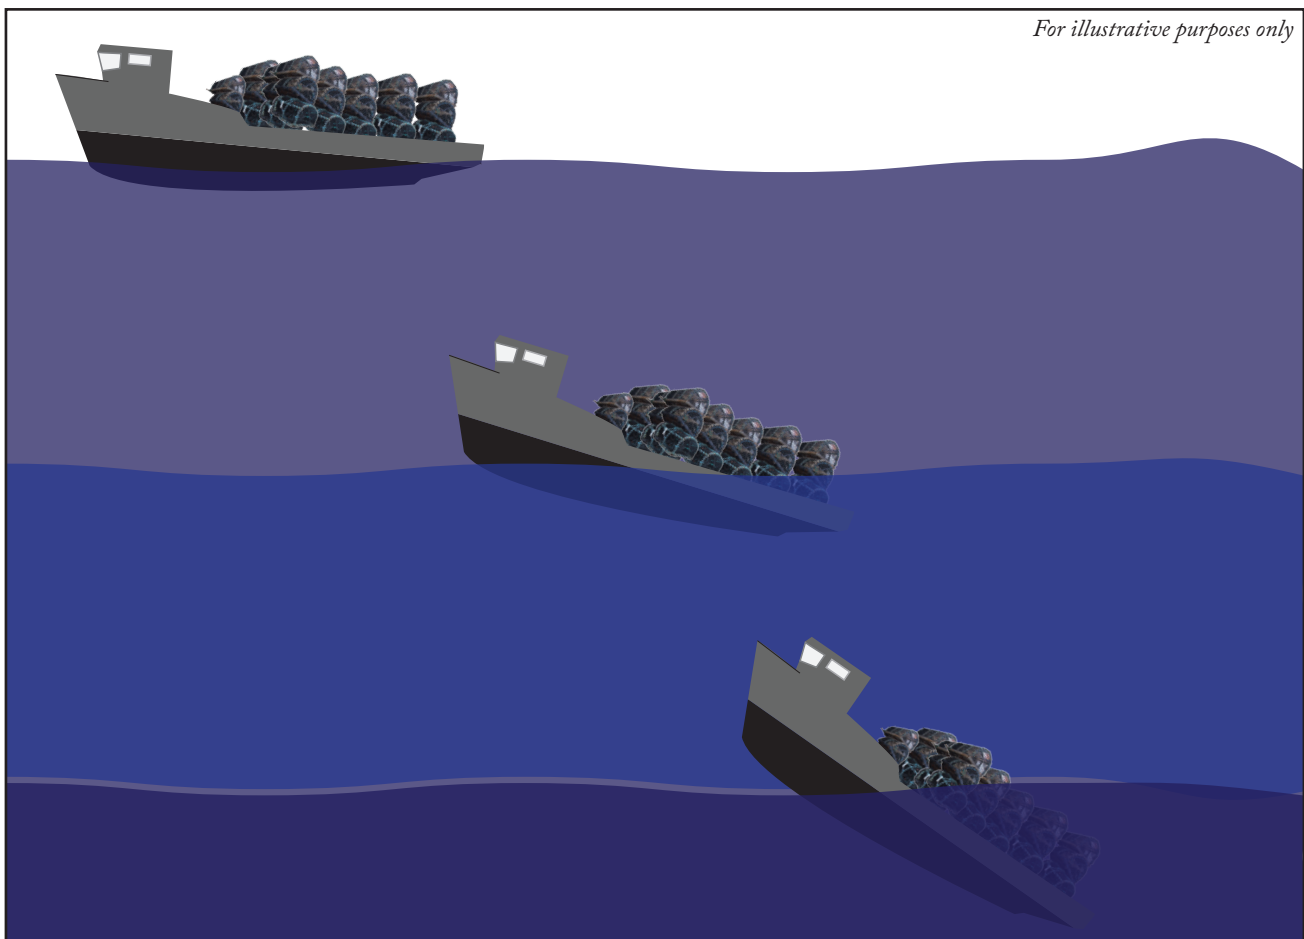
The skipper had previously disconnected the fish hold bilge alarm, relying solely on the engine room bilge alarm, which had been tested a week before the accident.

Behaviour of fishing vessel with heavy stern trim during flooding

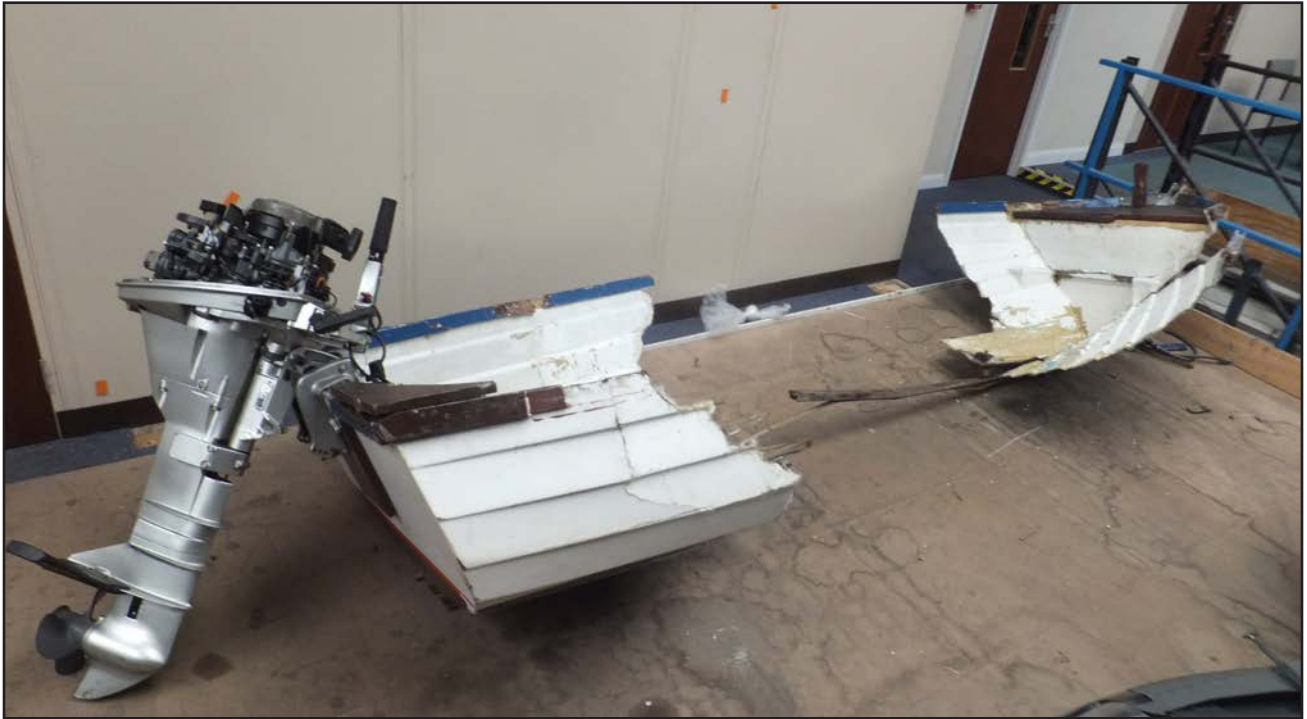
Four days later, two sections of the boat were found close together 35 miles east of the fisherman's location (Figure 1). It was concluded that he had not been wearing his kill cord (Figure 2) when he fell overboard and the boat's engine had continued to run with the propeller in gear. His boat was probably struck by a ship several days later.

Figure 1: Fishing vessel recovered sections
