MARINE ACCIDENT
INVESTIGATION BRANCH

SAFETY DIGEST

**Lessons from Marine
Accident Reports
2/2015**

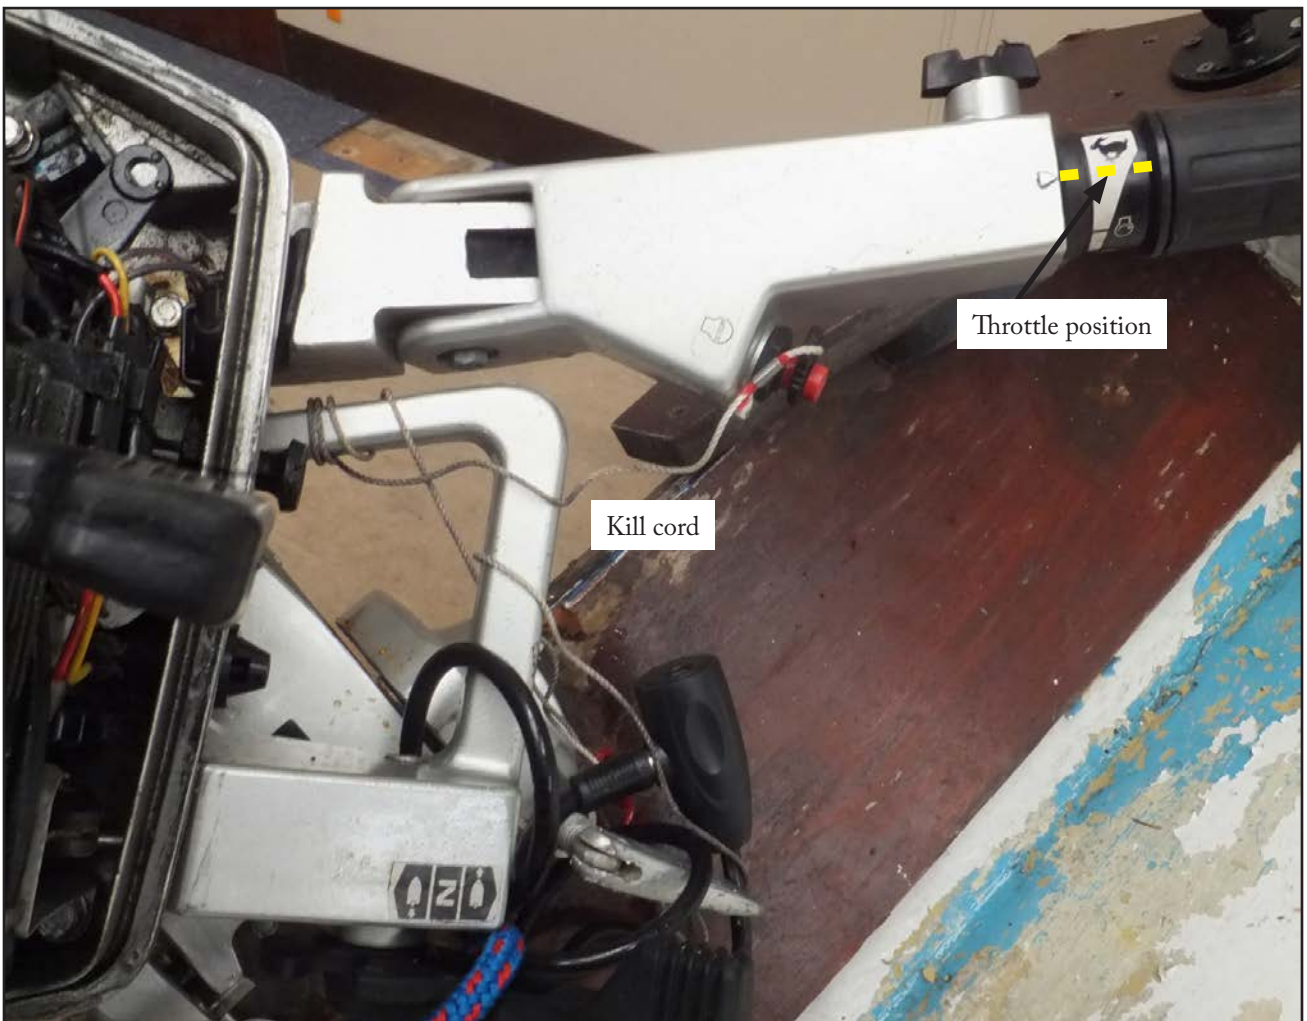
Four days later, two sections of the boat were found close together 35 miles east of the fisherman's location (Figure 1). It was concluded that he had not been wearing his kill cord (Figure 2) when he fell overboard and the boat's engine had continued to run with the propeller in gear. His boat was probably struck by a ship several days later.

Figure 2: Kill cord and throttle

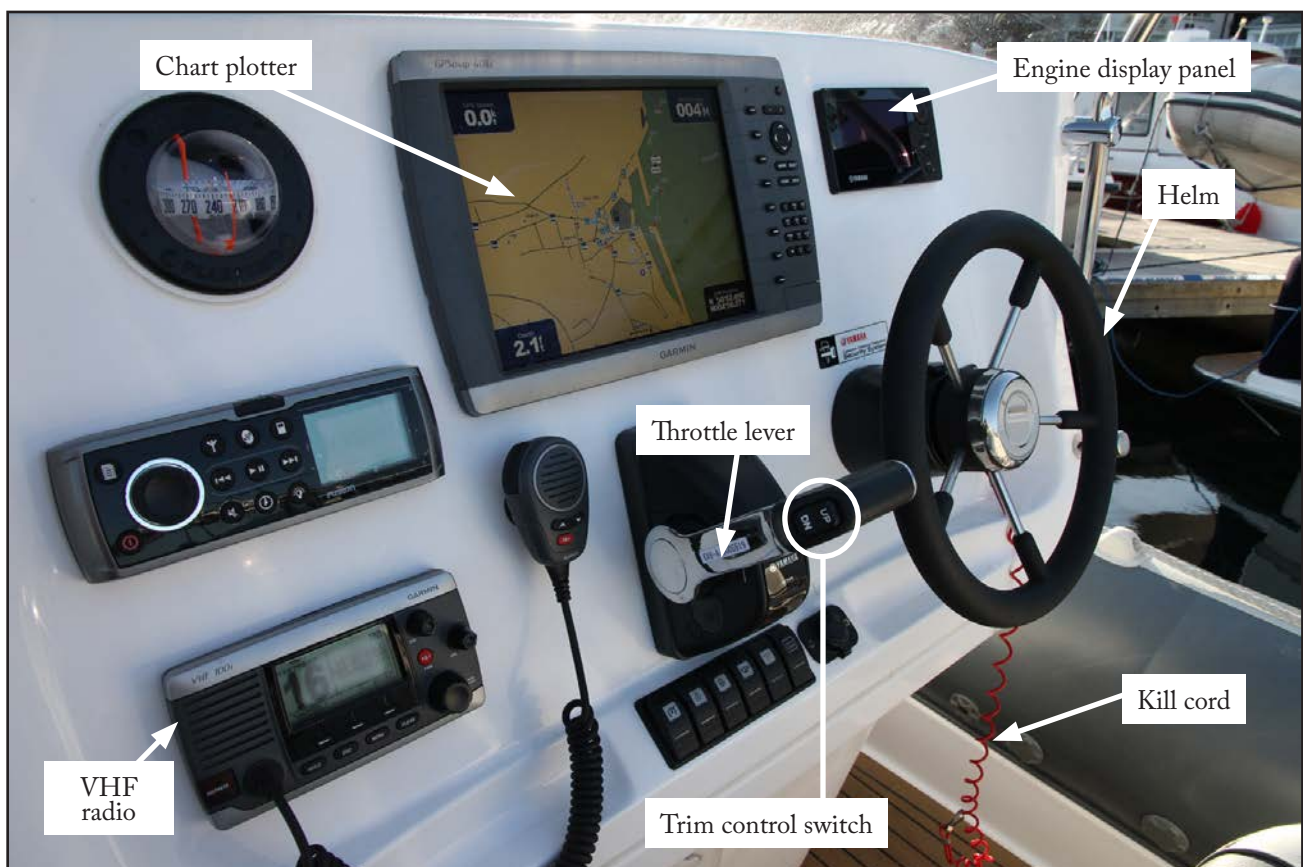
Figure 1: Steering console

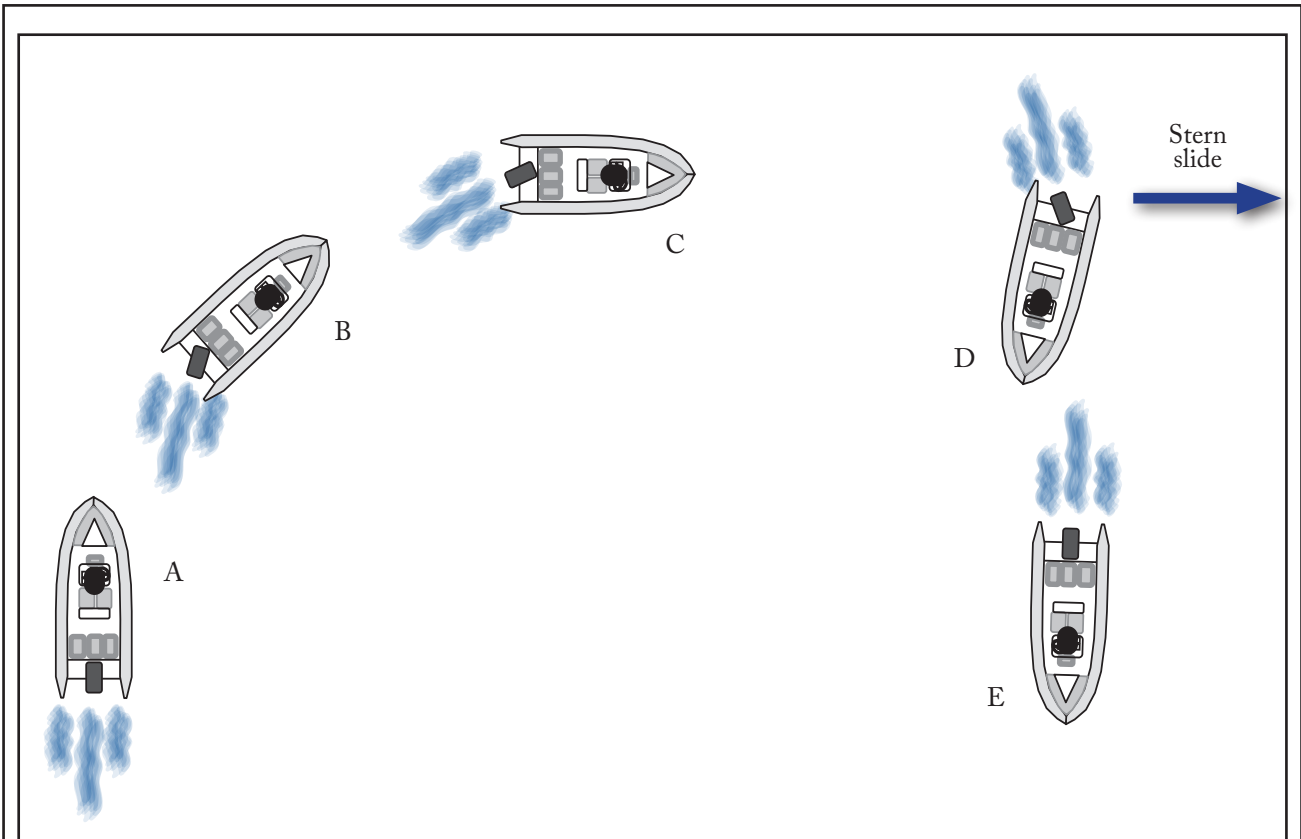
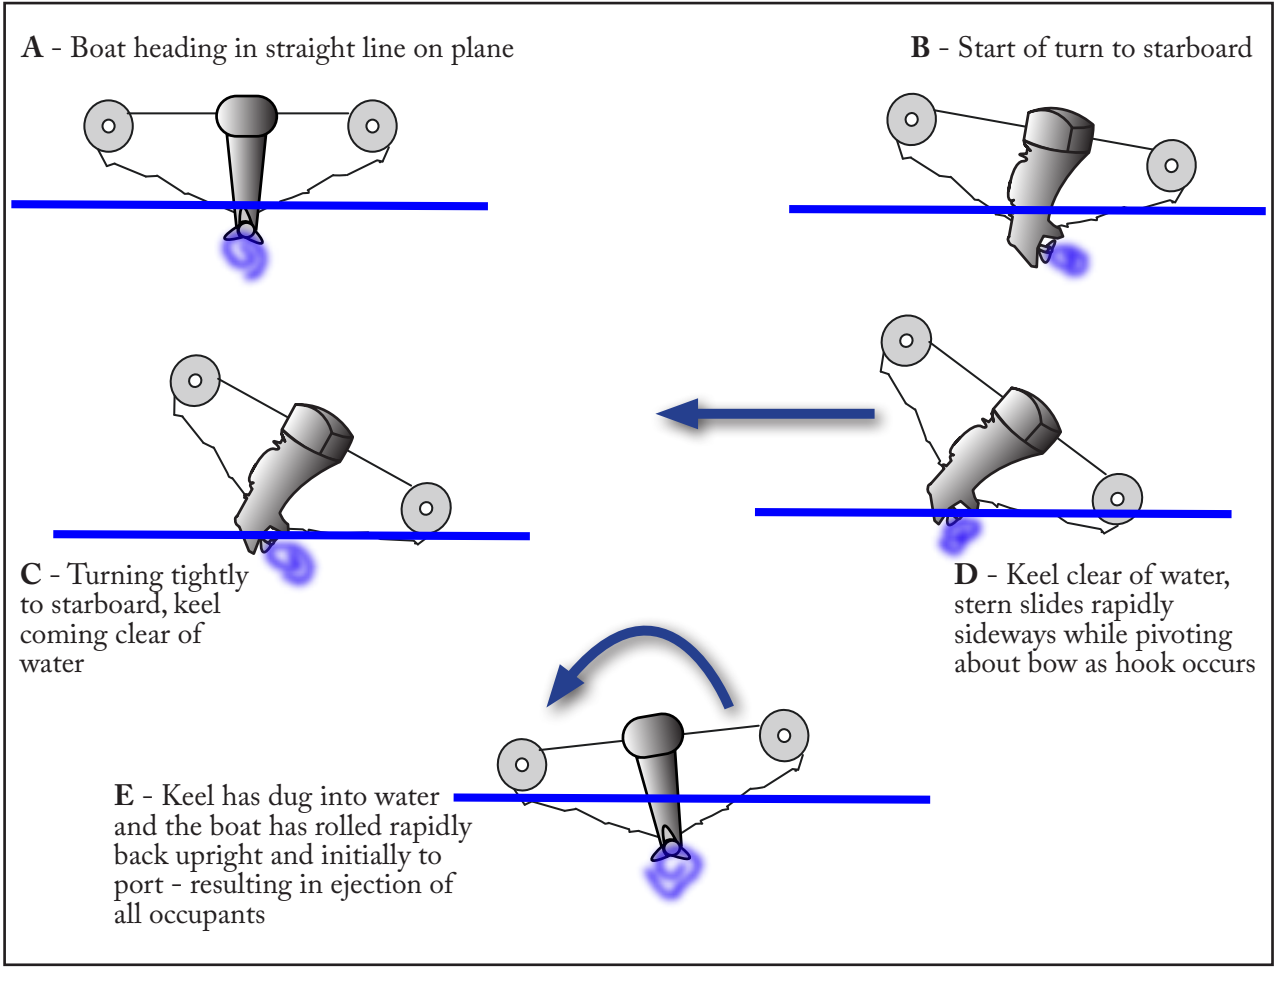
2. The adults did not have a good understanding of how the boat would perform in a high powered turn and were not prepared for the forces exerted when the boat 'hooked'. Entry level powerboat training courses may not be sufficient preparation for the safe operation of boats with powerful engines. Always ensure you are sufficiently well trained to safely handle your boat.

Figure 2: Diagram showing a hook during a turn

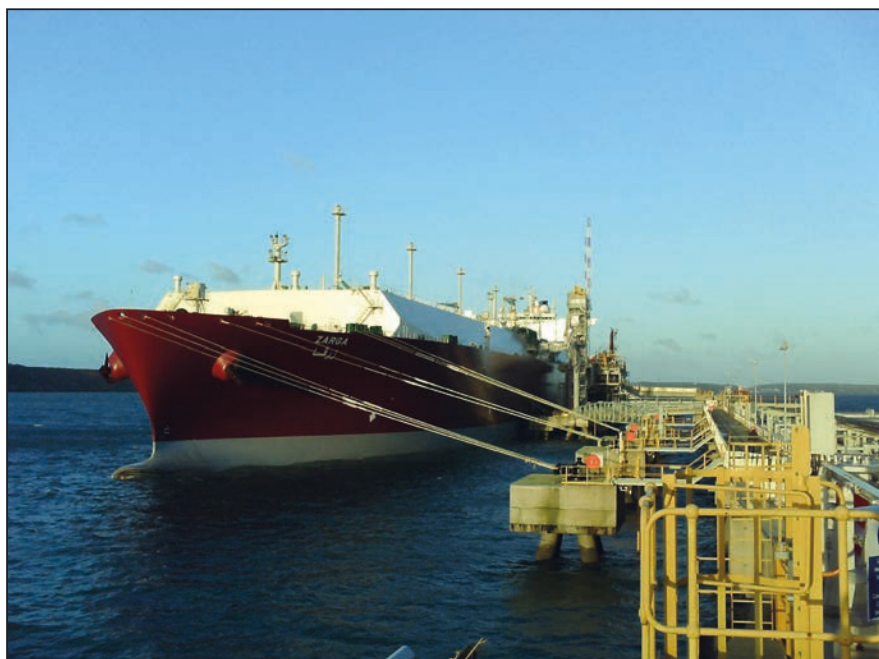
Figure 1: Zarga alongside South Hook LNG terminal

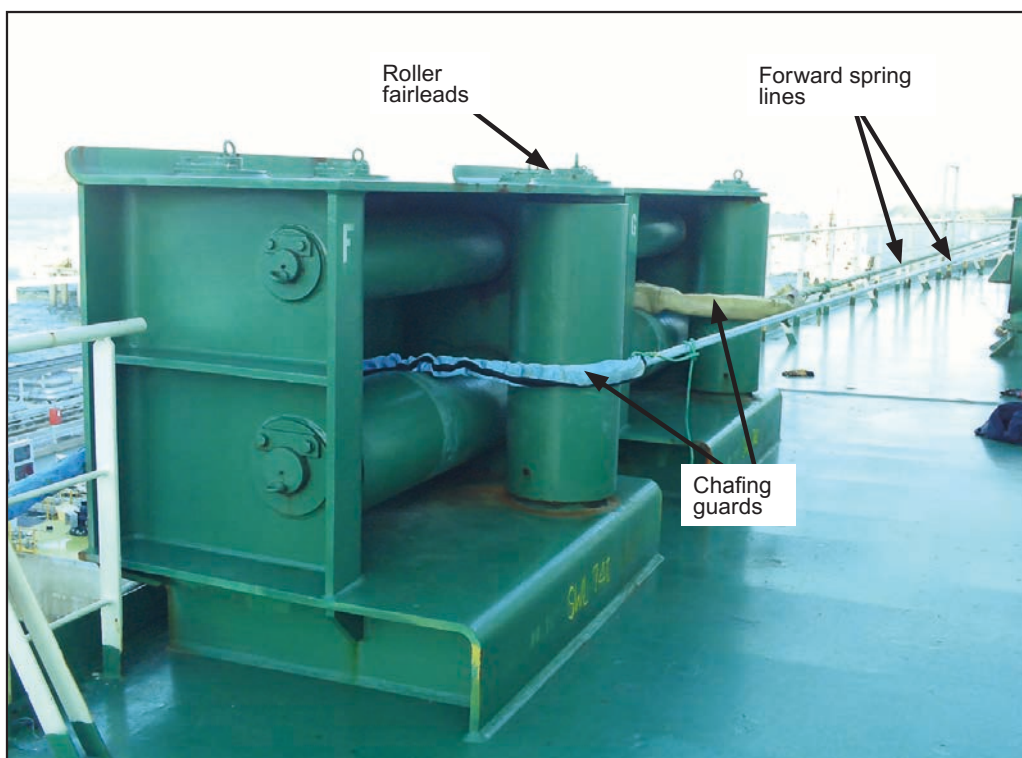
The OIC positioned himself aft of the forward springs' port-shoulder roller fairlead (**Figures 2 and 3**), and positioned a second crewman forward of him in order to relay his orders to the winch operator. As the winch operator attempted to heave in on the springs, the winch repeatedly stalled and rendered¹. After about 10 minutes, one of the spring lines began to rattle and creak, and then suddenly parted (**Figure 4**). The section of the line between the break and the port-shoulder roller fairlead struck the OIC on his head as it whipped back before going overboard through the fairlead.

Figure 2: Port-shoulder roller fairlead

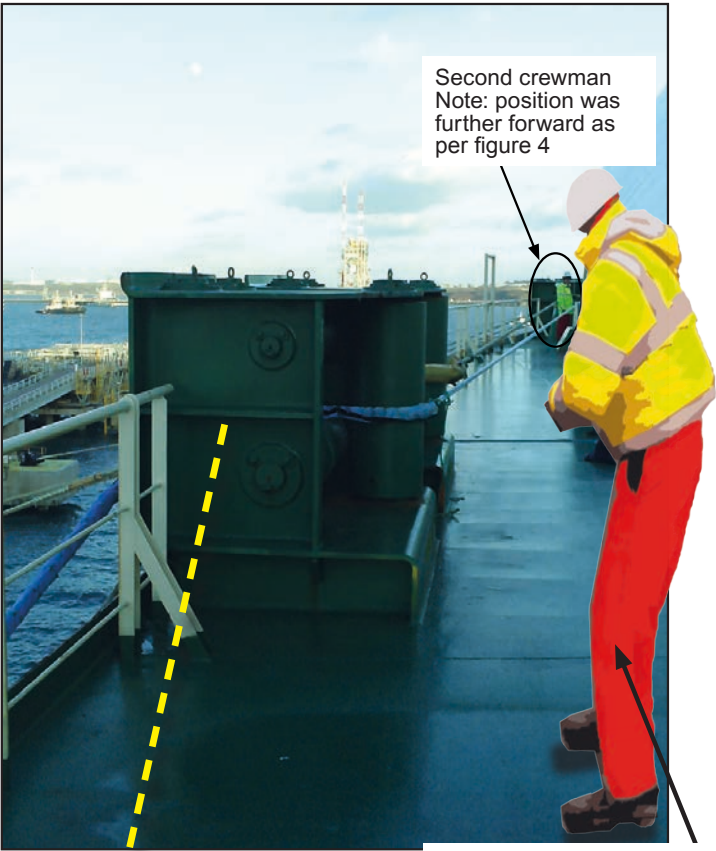
Figure 3: Forward mooring party OIC at port-shoulder roller fairlead

OIC forward mooring party

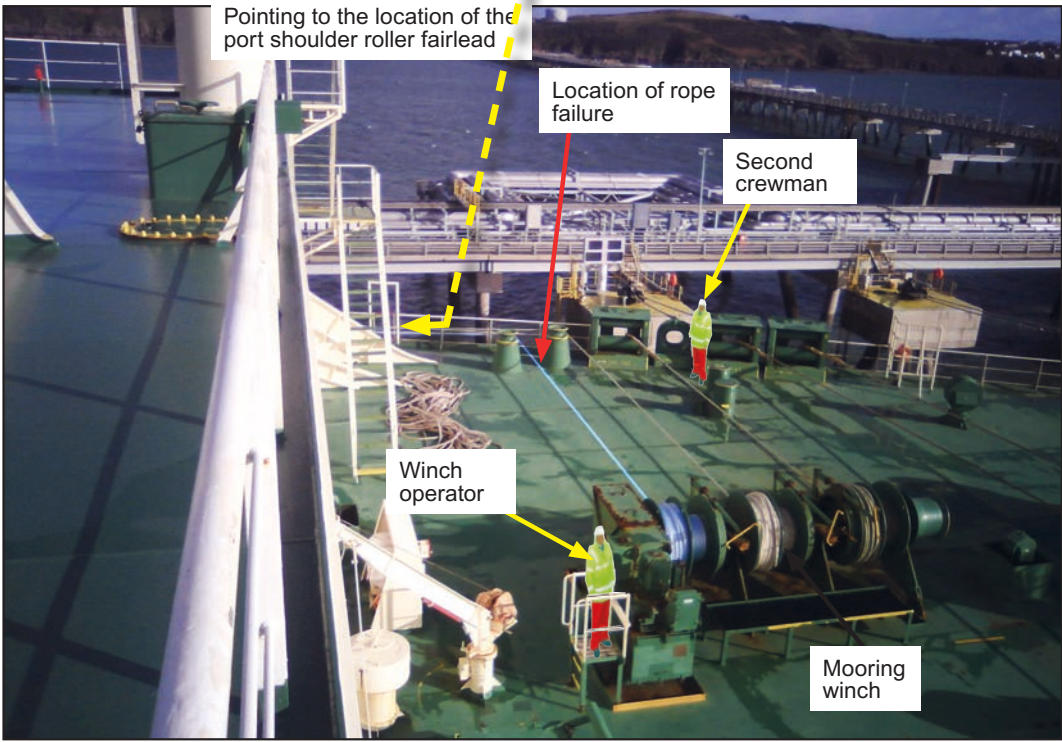
Figure 4: Port side forward mooring deck
