Report on the investigation
of the fatal crush accident
on the general cargo vessel

Karina C

at Seville, Spain

on 24 May 2019

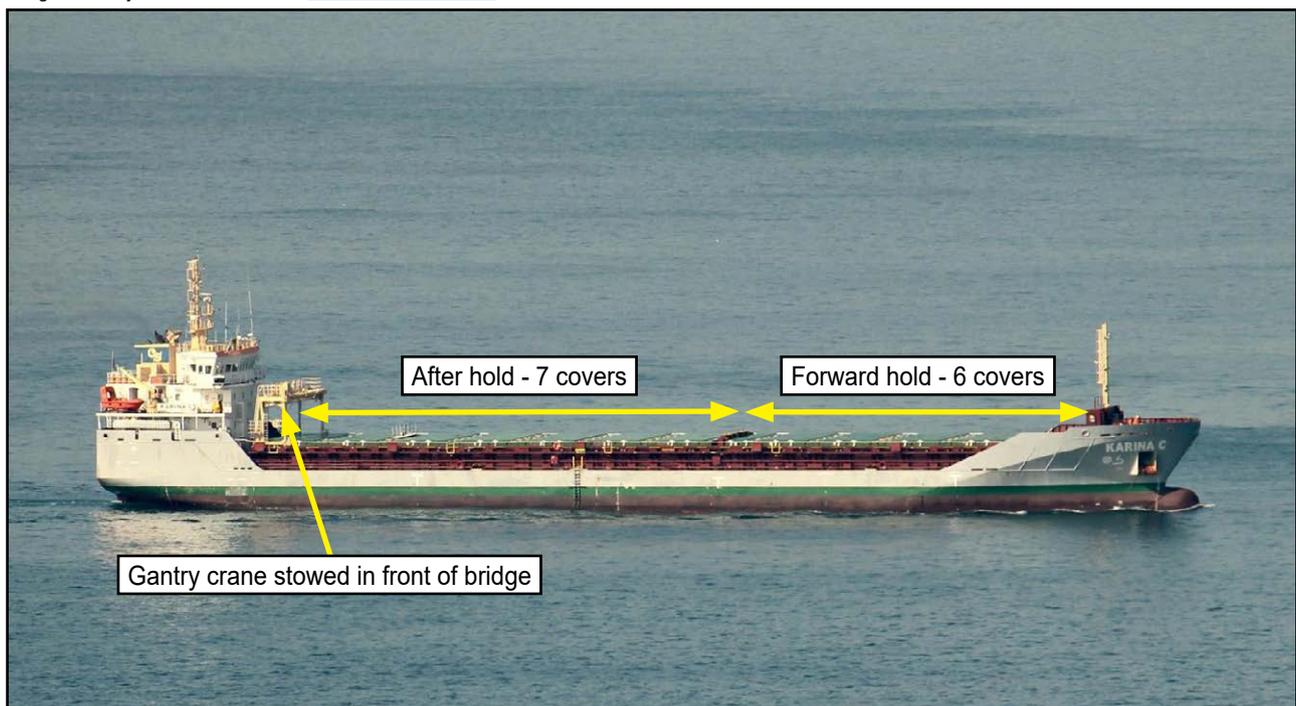
Figure 6: *Karina C*'s cargo hold and hatch cover arrangements

Karina C had two cargo holds; the forward hold had six pontoon-type hatch covers and the aft hold had seven (**Figure 6**). Each hold had a moveable partition bulkhead, which allowed further subdivision to accommodate different cargoes, giving a total of four hold compartments. Hatch covers and partition bulkheads were moved with the gantry crane. The hatch covers were not interchangeable and had to be placed onto the hatch coaming in sequence (**Figure 7**) before cleats were used to secure them. The coamings were provided with water drain channels.

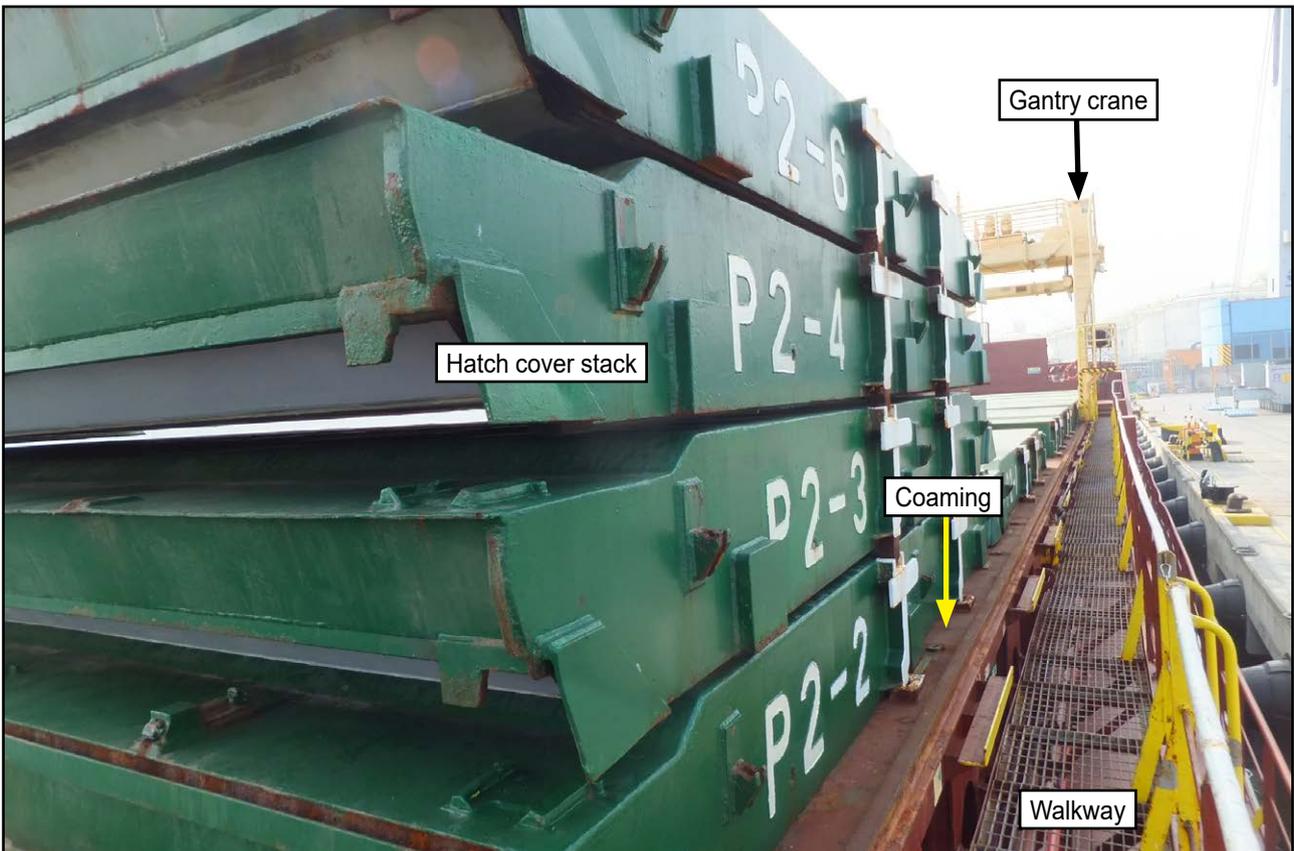
Figure 8: Starboard walkway showing stack of hatch covers and gantry crane

Hold access routes and ventilation ducts were located in the space between the two holds. Raised walkways, 1.67m from the main deck, ran along the length of the two holds on either side of the cargo hatch coamings (**Figure 8**).

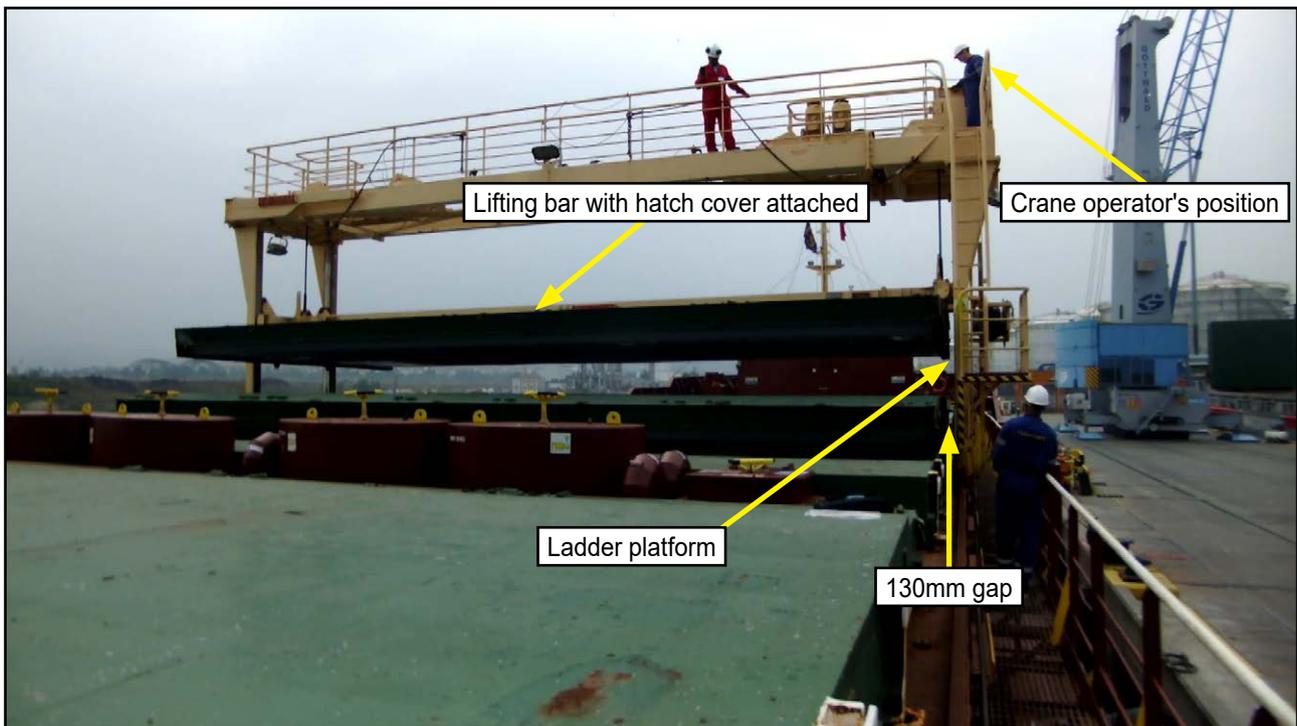
Figure 9: Gantry crane looking from aft

The operating position was located at the top of the crane on the starboard side. Access to the crane control platform was by one of two short vertical ladders (one from the starboard walkway, the other from the top of the hatch covers) to an intermediate platform, and then an inclined ladder to the top. The vertical distance between the raised walkway and the crane operator's platform was 4.75m (**Figure 9**).

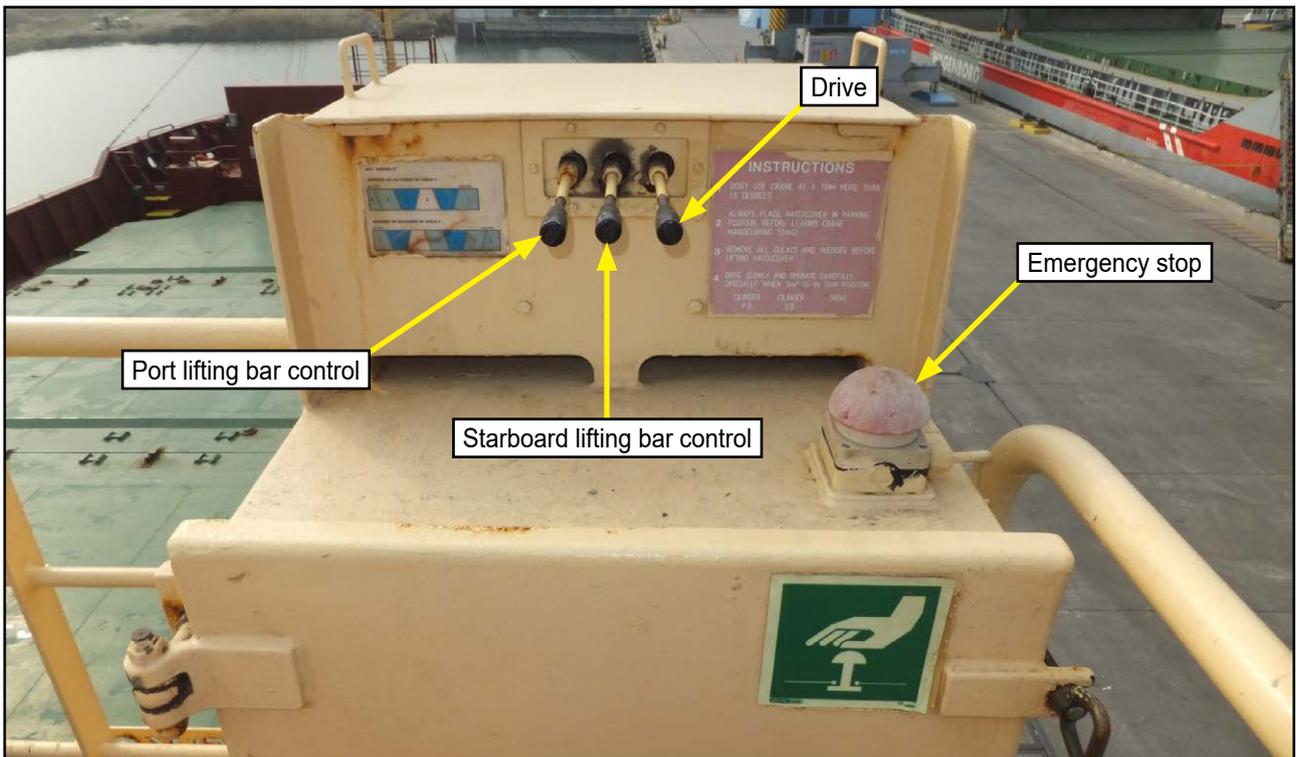
Figure 10: Gantry crane control panel

The crane had three control levers: two for operating the lifting bar through hydraulically-operated cylinders and wires, and one for driving the crane forward or aft (**Figure 10**). The drive lever had three positions: forward, stop and reverse. The crane speed was variable depending on the position of the drive lever; at the extreme end position of the lever, the crane reached a speed of 20m/minute. Bringing the drive lever to stop applied brakes on the two forward wheels.

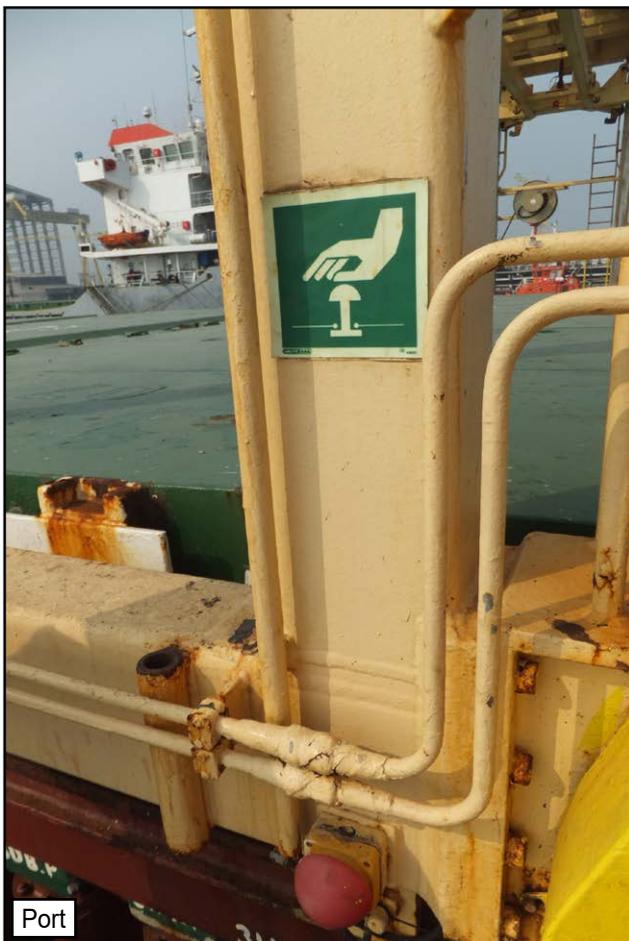
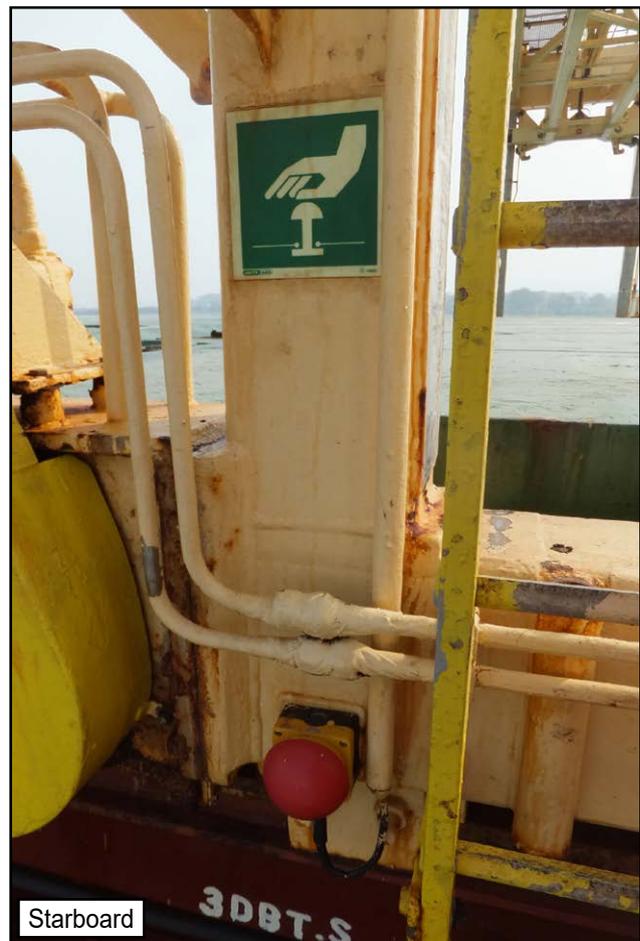
Figure 11: Gantry crane emergency stops

The crane had three emergency stops; two at walkway level on the outboard sides of the port and starboard aft crane legs (**Figure 11**) and one at the driving position (**Figure 10**). To operate the port or starboard emergency stops, a crew member needed to be stationed on the outboard side of the crane between the crane and the walkway guardrail. The gap between the crane and the guardrail was about 350mm wide (**Figure 12**).
