MARINE SAFETY INVESTIGATION REPORT

Safety investigation into a fatality and serious injuries on board the
Maltese-registered passenger/ro-ro vessel

Euroferry Malta

MARINE SAFETY INVESTIGATION REPORT NO. 17/2020

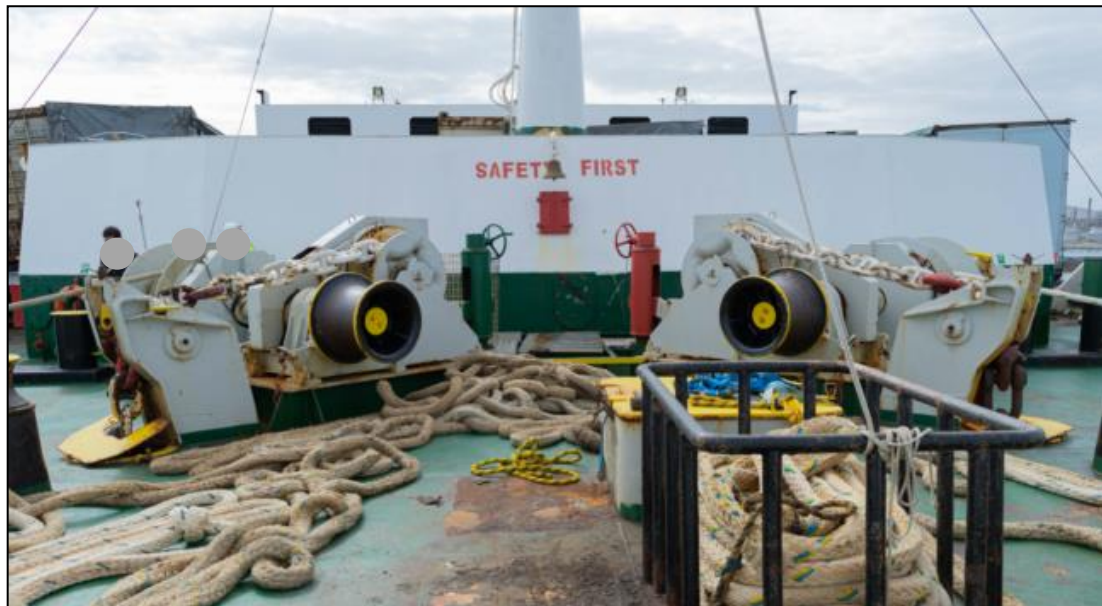
Figure 3: Deckhouse, as seen from forward

A deckhouse (Figures 3, 4 and 5) separated the forecastle of the vessel from the upper deck. The aft section of this deckhouse contained an access, leading to the stores and cargo holds, and the ventilation systems of these spaces. The forward bulkhead of the deckhouse served as a wave breaker.

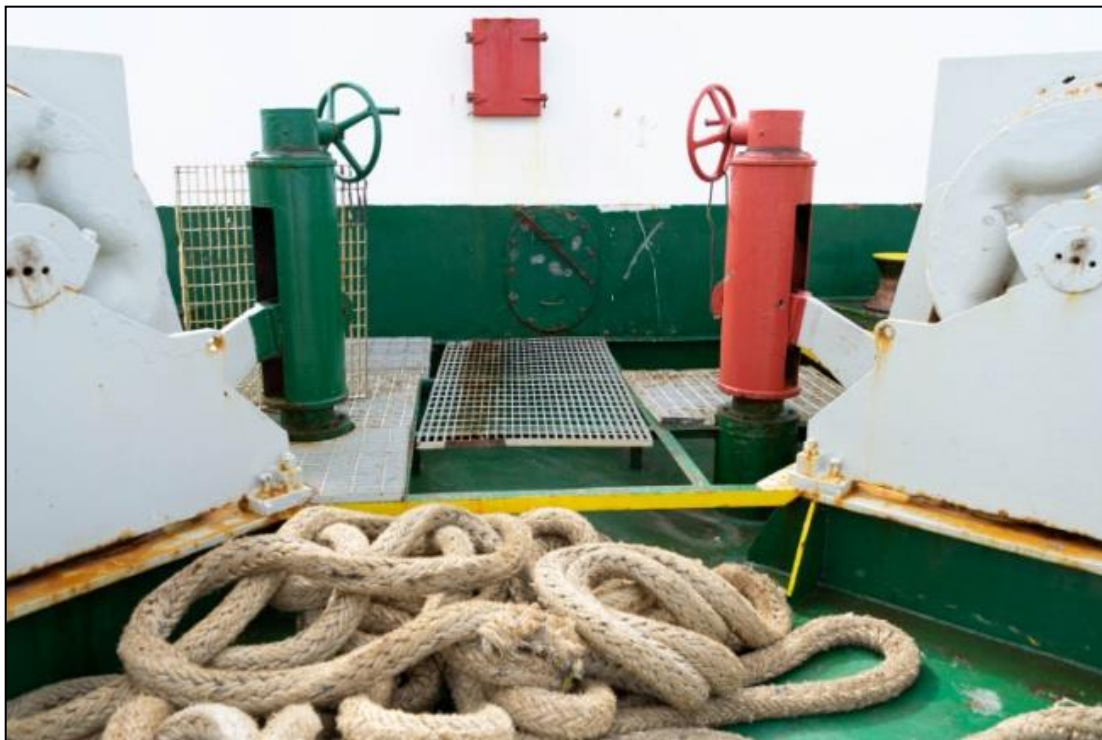
Figure 6: Handwheels to operate the brakes of the windlasses (port windlass brake – red; starboard windlass brake – green)

The securing arrangements for each anchor included the brake, tightened or slackened via a handwheel (Figure 6), and the chain stopper (indicated by the red arrow in Figure 7). In addition, arrangements were made by the crew members to add additional securing devices, as required. This arrangement consisted of a steel wire, chain and turnbuckle, secured via shackles to the windlass (Figure 8).

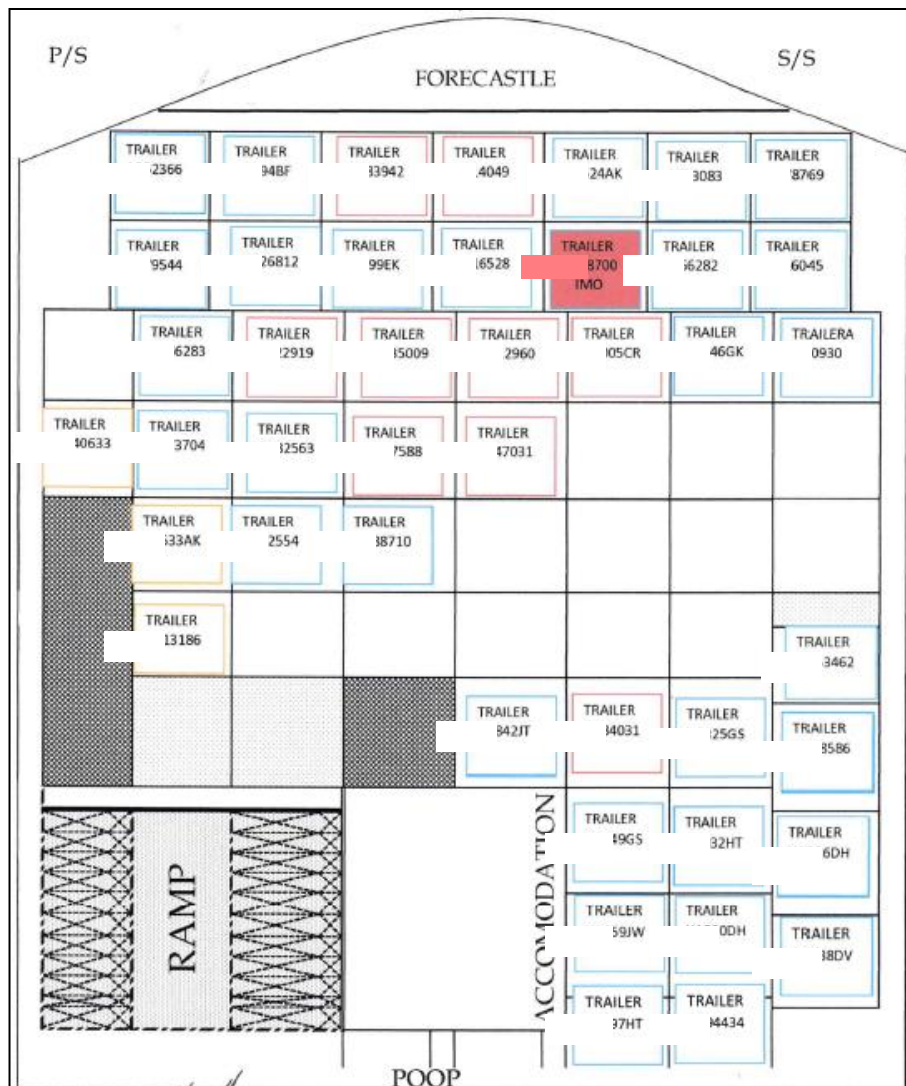
Figure 9: Stowage Plan for Deck 4

43 trailers were stowed on Deck 4 of which, 14 were stowed in the unsheltered foremost location of this deck (Figure 9).

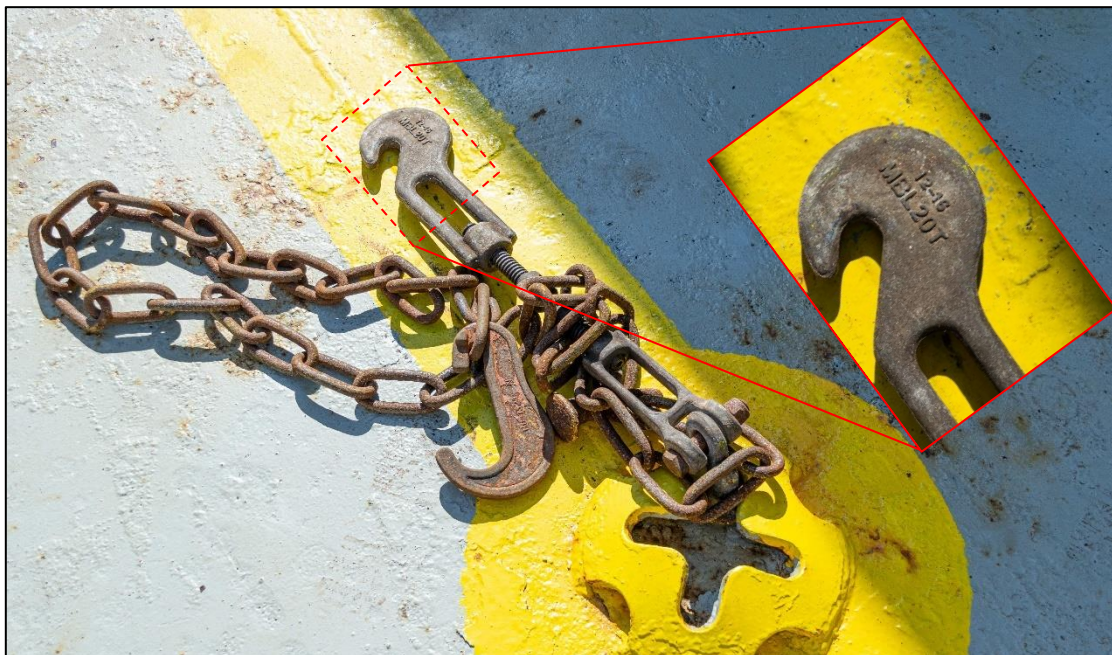
Figure 10: Cargo securing device (chain, hook and turnbuckle)

Although the software program only made reference to maximum securing loads (MSL) of 9.99 mt, it was observed that vessel was provided with a number of securing devices which had a maximum breaking load of 20 mt (Figure 10). The chief officer stated that only 20 mt cargo securing devices were used on board.

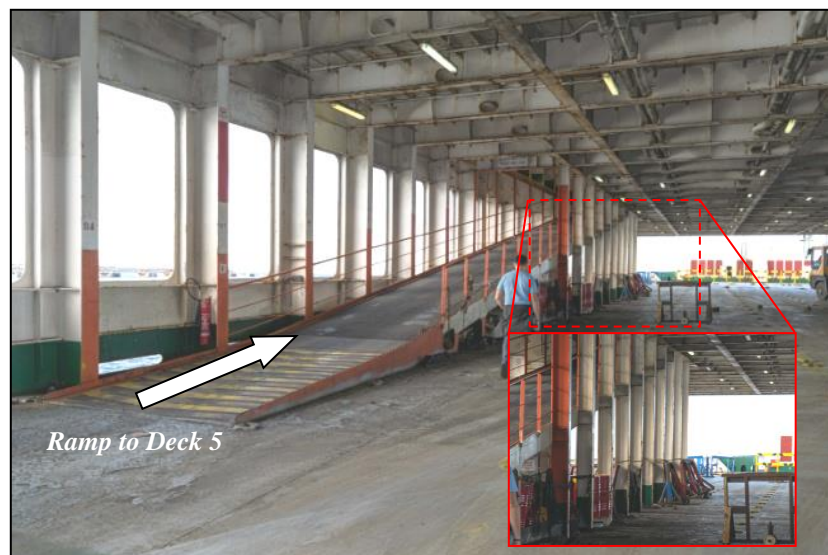
The ABs and the OS waited in a sheltered area under the ramp (Figure 11) on the port side, while the chief officer and the bosun went forward to check the damaged trestles and landing gear of the trailers on the starboard side, in order to plan a further course of action. Whilst the chief officer was surveying the area, he realized that the bosun was not around.

Figure 11: Area where the crew members were waiting (inset – zoomed), before the accident.
