## SAFETY INVESTIGATION REPORT

REPORT NO.: 18/2019

**MV MAERSK JAIPUR**  
**Fatal accident in the Engine-room**  
**in position 54° 18.9' N 164° 26.9' W**  
**08 October 2018**

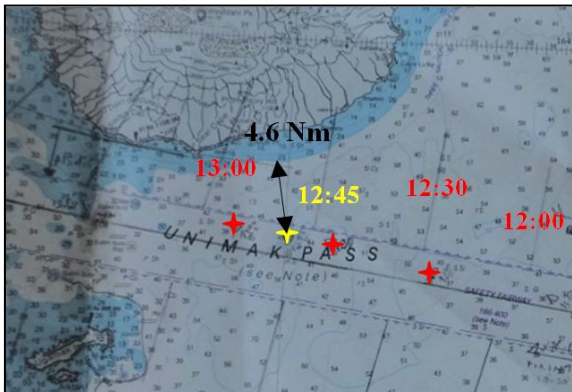
At the time of the accident, *Maersk Jaipur* was transiting through the safety fairway at a speed of 12 knots, and the closest distance from shallow waters was approximately 4.6 nm to starboard (Figure 3). The closest boundary of the safety fairway was lying on her starboard side at about one nautical mile distance.

**Figure 3:** Extract from Nautical Chart in use, showing the positions of the vessel at the start of the Unimak Pass. Position indicated in yellow (12:45) is the time that the Fitter was fatally injured.

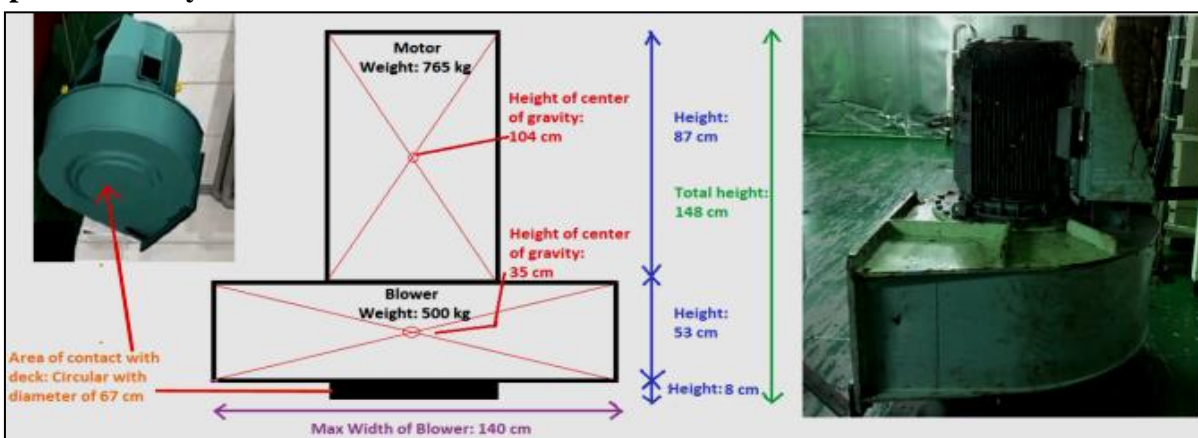
**Figure 4:** Dimensions of the auxiliary blower

Two spare auxiliary blowers, each weighing approximately 1300 kg, were secured on the upper platform of the engine-room, which was level with the main deck. These units had a circular base, with a diameter of 67 cm, which made contact with the deck and were approximately 148 cm high (Figure 4).

Each blower was placed among four steel angles, each 6.35 mm thick, welded to the deck. In addition, each blower was secured to the deck using four plastic sheathed steel cables, each having 6.35 mm diameter, which were fastened with turnbuckles connected to floor eyebolts. All lashing wires led up at angles of more than 60° from the horizontal. No dunnage was placed under the blowers (Figures 5 and 6).

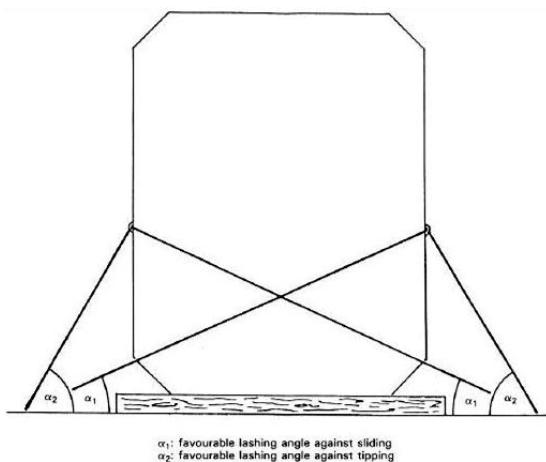
- the securing devices should be arranged in a way to withstand transverse and longitudinal forces which may give rise to sliding or tipping;
- the optimum lashing angle against sliding is about  $25^\circ$ , while the optimum lashing angle against tipping is generally found between  $45^\circ$  and  $60^\circ$  (figure 8); and
- if, owing to circumstances, lashings can be set at large angles only, sliding must be prevented by timber shoring, welded fittings or other appropriate means.

**Figure 8: Extract from the CSS code - Principles of securing heavy items against sliding and tipping**
