Crew member fatality on board *Toucan Arrow*

Portland, Victoria | 7 October 2013

ATSB Transport Safety Report
Marine Occurrence Investigation
303-MO-2013-010
Final – 16 June 2014

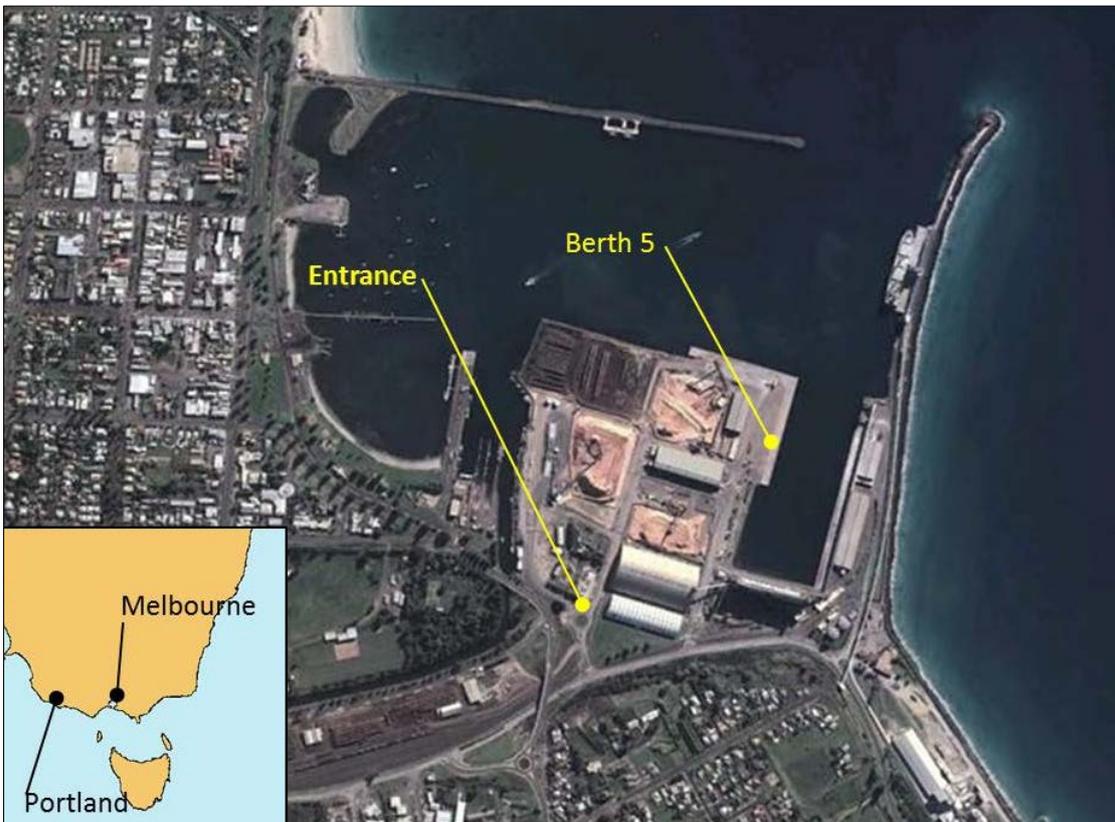
Figure 3: Port of Portland showing the berth and the port's main access point.

The port (Figure 3) is located about 300 km west of Melbourne, the capital of the State of Victoria. It is an outlet for the extensive agricultural and pastoral country of the western part of Victoria and also serves a large aluminium smelter and fertiliser plant. Fishing vessels also operate from the port.
