Report on the investigation of
wave damage to the
passenger cruise ship
Oriana
in the North Atlantic Ocean
28 September 2000

Marine Accident Investigation Branch
First Floor
Carlton House
Carlton Place
Southampton
United Kingdom
SO15 2DZ

Report No 36/2002
November 2002

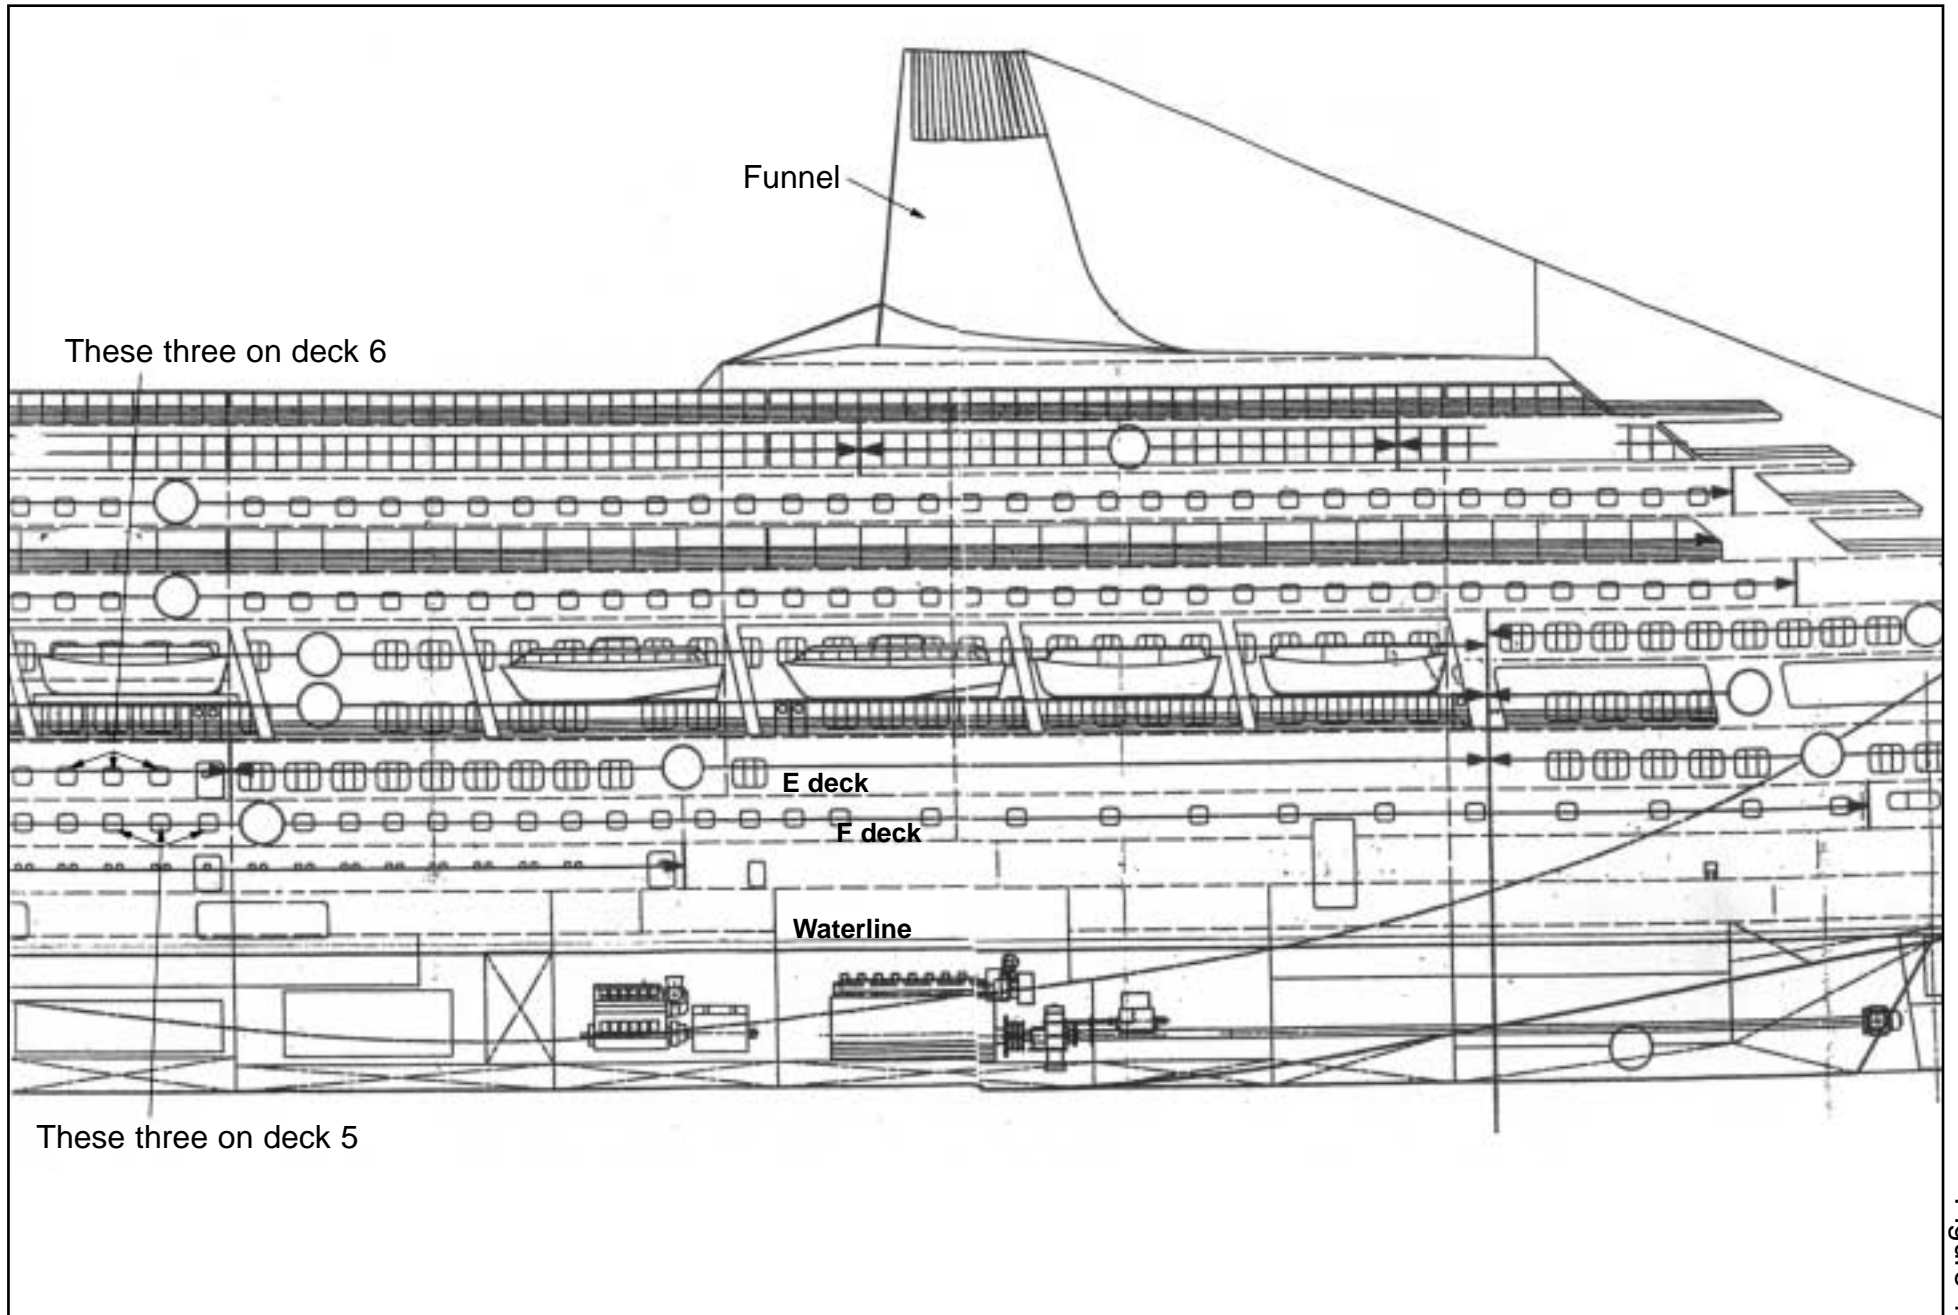
Figure 1

The position of the damaged windows is shown in **Figures 1 & 17**. The cabins affected were F176, F178, F180, E172, E174 and E176, all of which were situated approximately amidships on the port side (**Figure 18**).

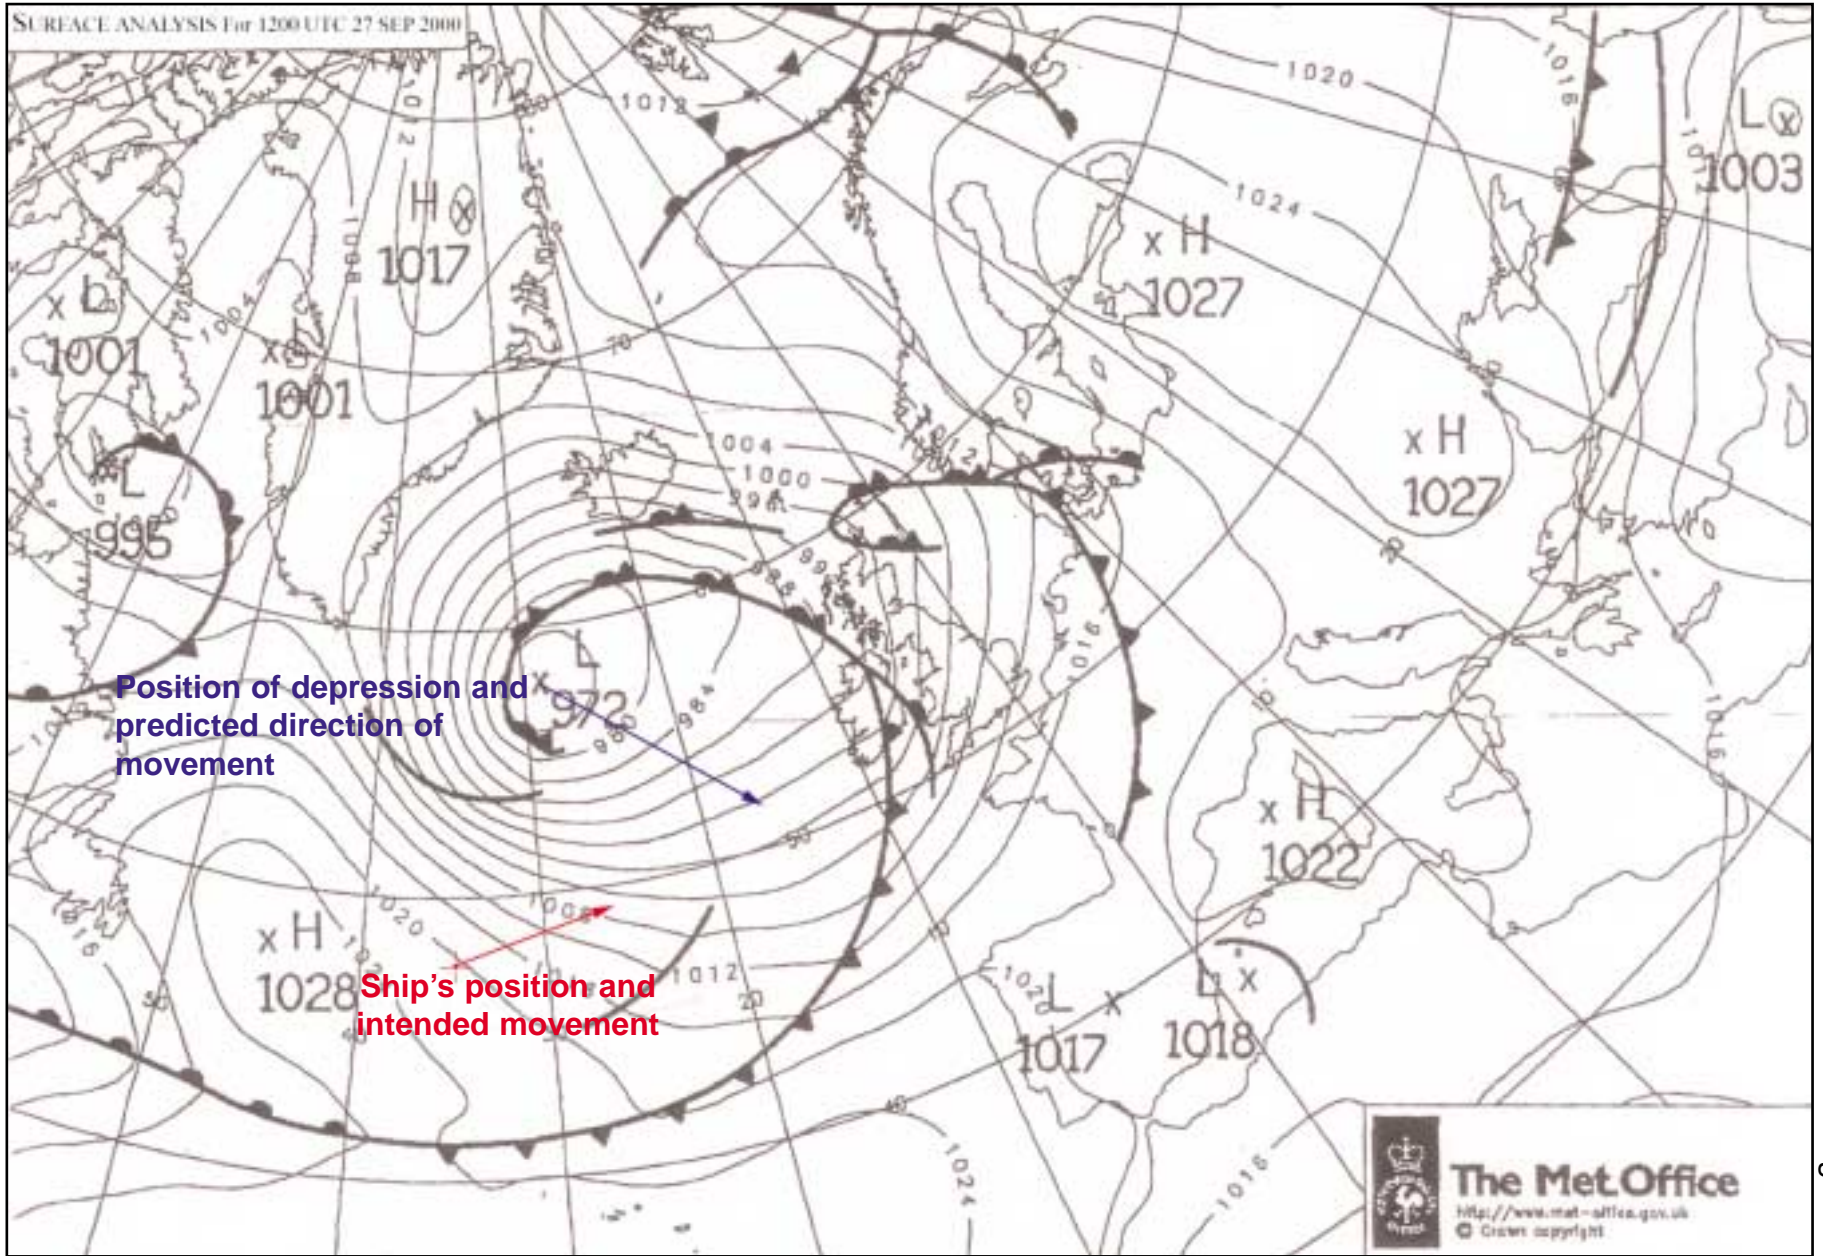
Figure 6

Aware that the depression had, or was about to, change direction to the south-east towards the ship's planned track, the captain ordered its actual and predicted positions to be plotted on chart BA 4011, a widely used chart of the North Atlantic. The positions plotted were taken from Meteo France forecasts at 0900 and 2100 daily. The path of the depression as plotted by *Oriana*, based on data supplied by Meteo France, is shown at **Figure 2**. Additionally, the ship's position was plotted on surface analyses and prognoses issued by the MO. Based on this information, the captain assessed that by reducing speed to 19.5 knots on the evening of 27 September, the ship would remain sufficiently clear of the depression to avoid the worst of the storm force conditions. The MO surface analysis for 1200 on 27 and 28 September, with the ship's position marked, is shown at **Figures 6 and 7**.

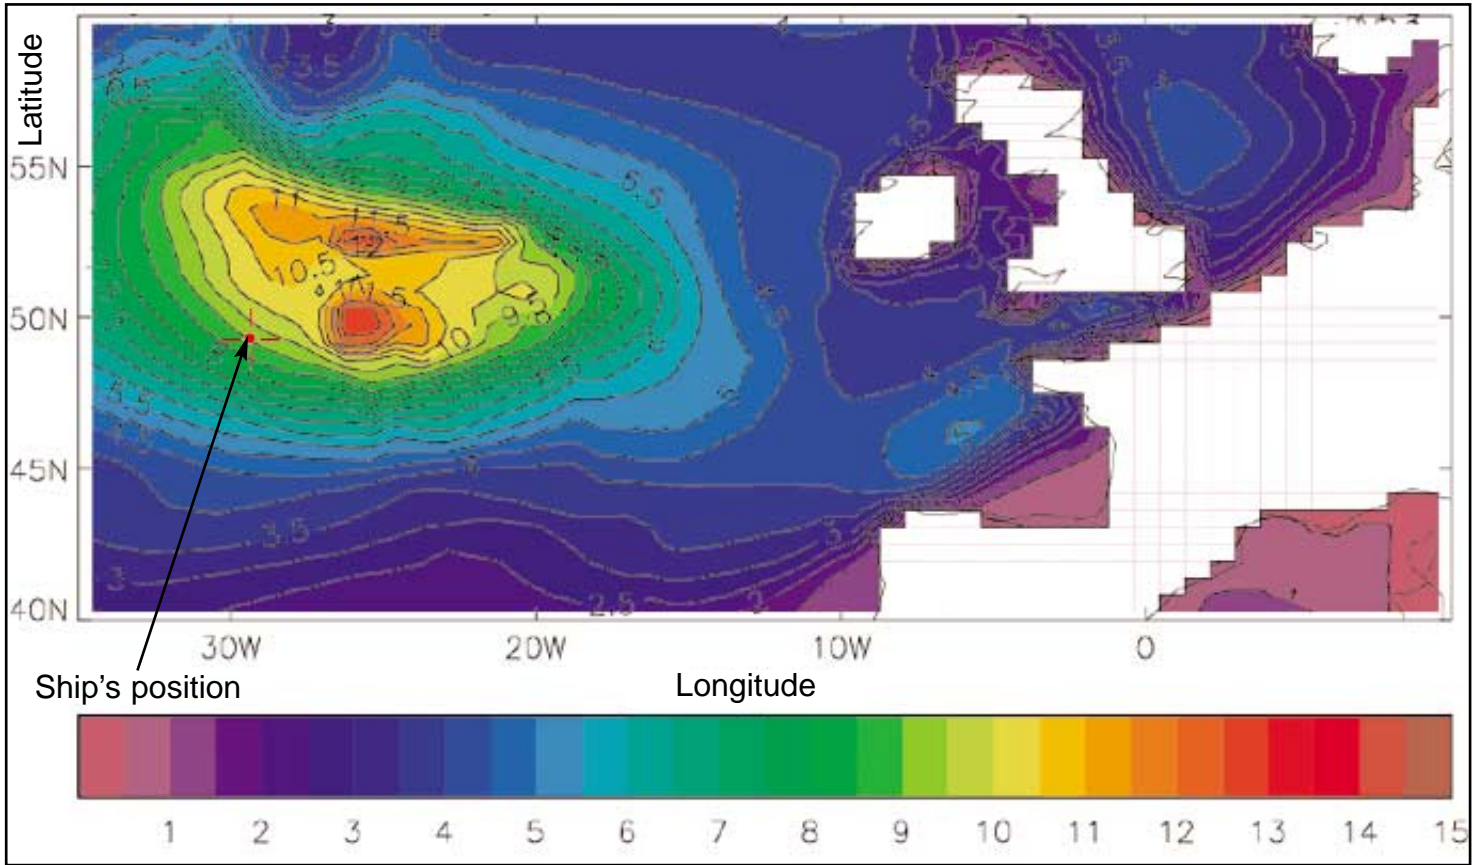
Figure 12

Significant wave height is defined as the average height of the highest third of the waves, and wave height is measured from crest to trough. Diagrams showing predicted significant wave heights for 0000 and 1200 on 28 September 2000, along with the ship's positions at these times, are at **Figures 12 and 13**. In a typical storm the expected height of the highest wave is usually 1.8 to 2.0 times the size of the significant wave height. There is, however, about a 1% chance of a wave 2.5 times the size of the significant wave height being encountered.

Diagram showing Significant Wave Heights for 00Z on 28 September 2000

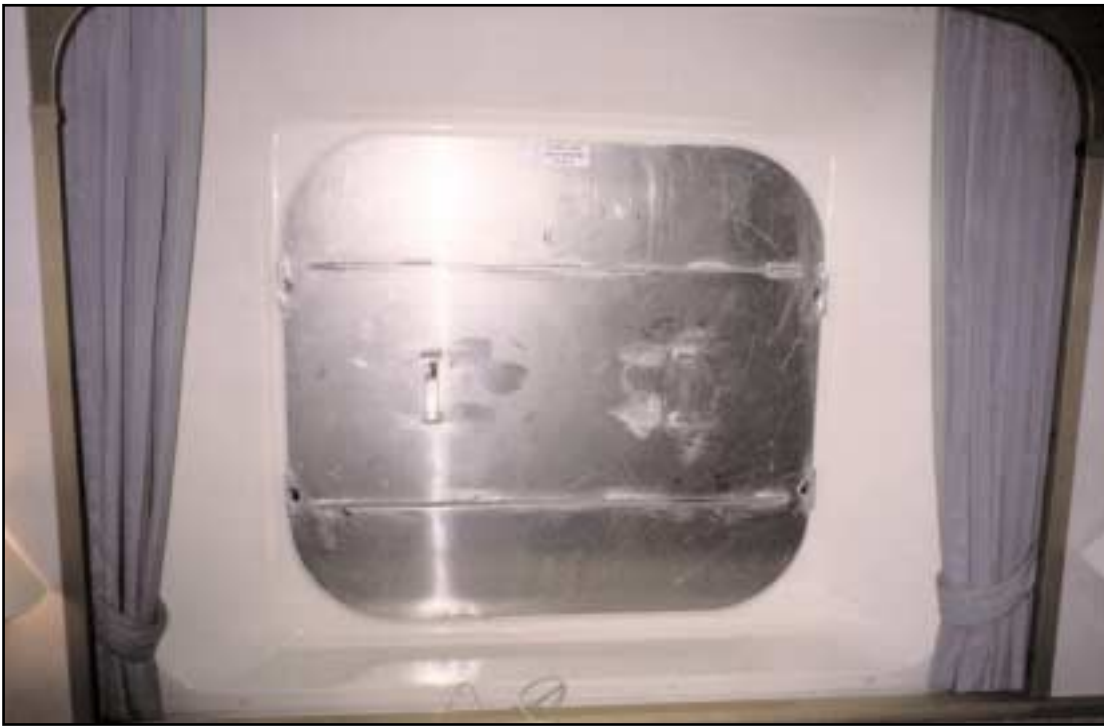
Figure 24

When the windows fitted with storm covers on deck 5 were breached, the storm covers were forced off their mountings by the pressure of the water. The sockets cut in the sides of the storm covers were ruptured as they were pushed off the lugs (**Figure 24**). The storm covers were also bowed.

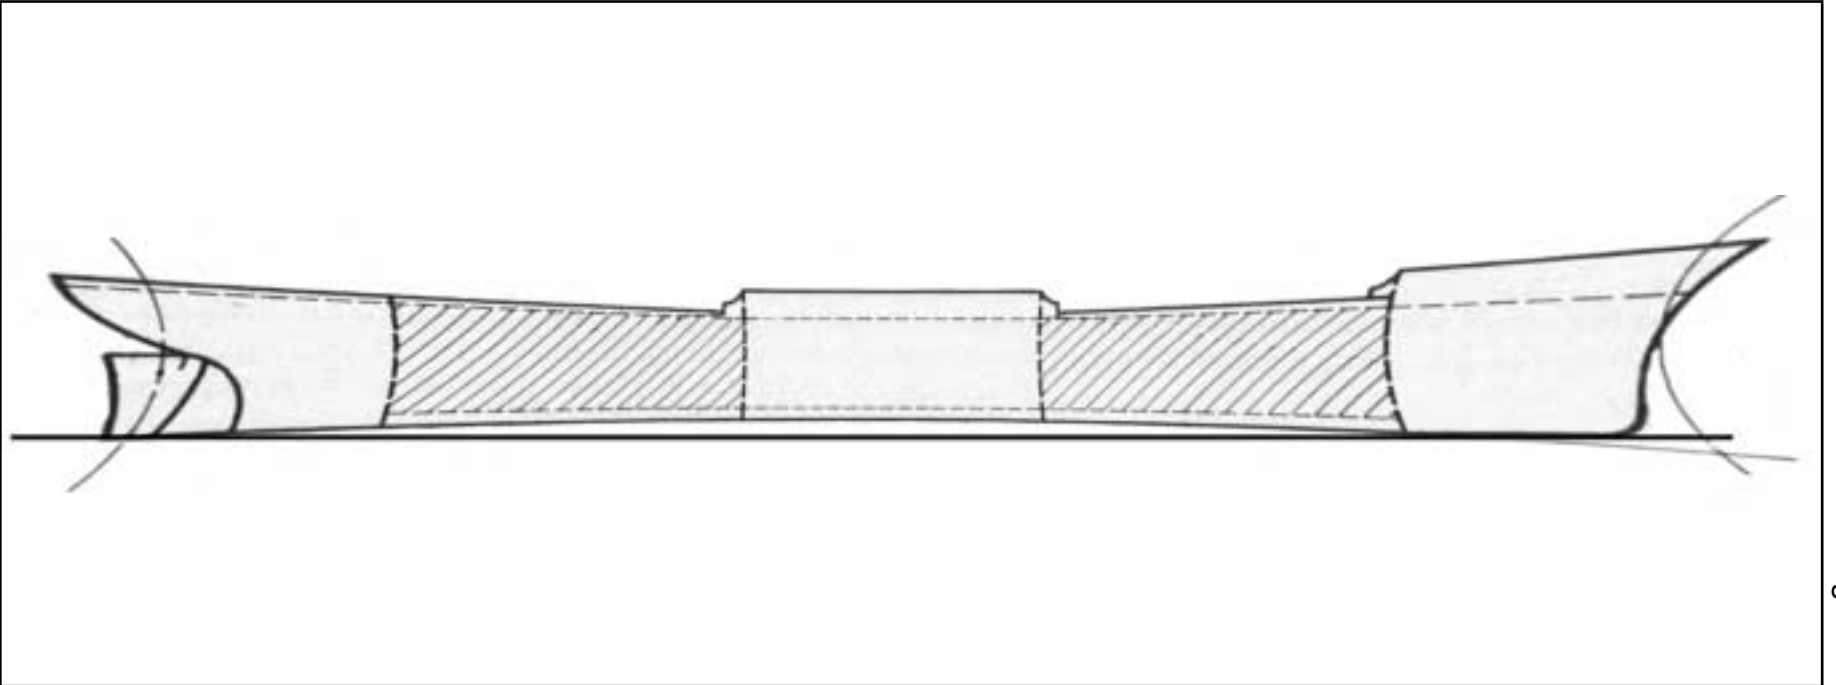
Figure 28

- B-0 fire rating - Capable of preventing the passage of fire to the end of the first half hour of a standard fire test.
- Hogging - The deviation of the keel from the horizontal when the keel is concave downward, ie the upper decks are in tension and the keel is in compression. **(Figure 28)**
- Hove-to - Due to the stress of the weather a vessel is manoeuvred so as to ride out the storm in the most comfortable position. This is usually achieved by heading into the sea and swell at very slow speed.
- Mullion - A vertical support in a window frame.
- Yaw - The unavoidable oscillation of the ship's head either side of the course being steered or when at anchor, due to wind and waves.

Illustration of hogging
