National Transportation Safety Board

Marine Accident Brief

Allision of Bulk Carrier *Anna Smile* with Louis Dreyfus Grain Elevator

Accident no.	DCA14LM013
Vessel name	<i>Anna Smile</i>
Accident type	Allision
Location	Louis Dreyfus Grain Elevator dock, Woodhouse Terminal, Houston, Texas 29° 43.16' N, 95° 14.22' W
Date, time	July 14, 2014 0504 central daylight time (coordinated universal time – 5 hours)
Injuries	None
Damage	Grain elevator: approx. \$2.5 million <i>Anna Smile</i> : estimate not provided
Environmental damage	None
Weather	Light winds 4 knots, visibility 10 miles, air temperature 79° F
Waterway information	Houston Ship Channel

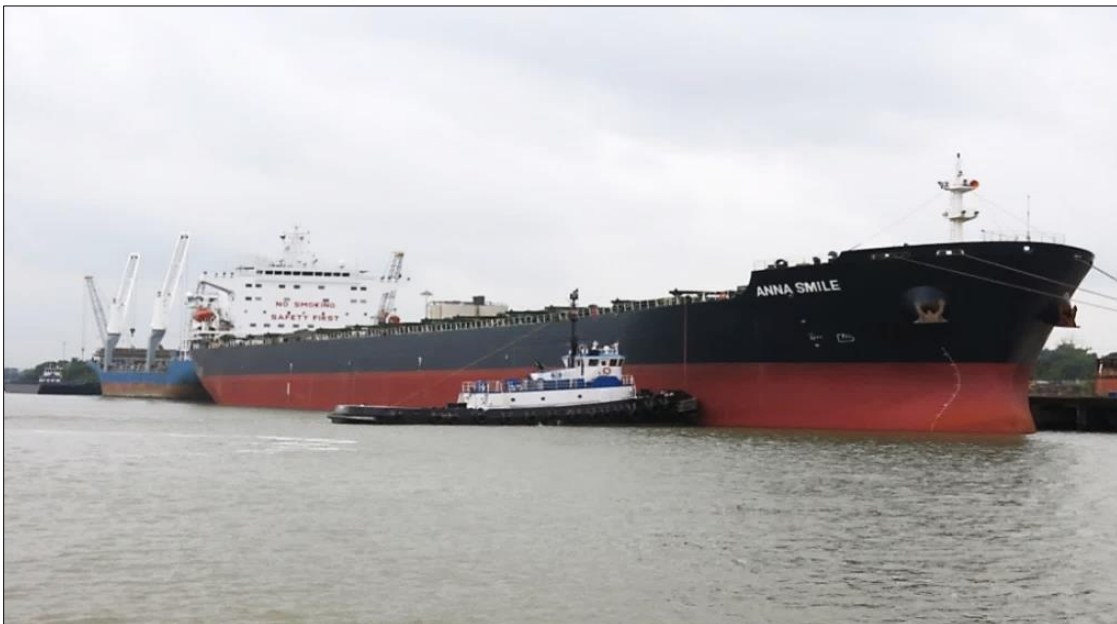
After the accident, the bulk carrier *Anna Smile* was berthed in the Houston Ship Channel upriver from the site of the allision.
