Mariners' Alerting and Reporting Scheme

MARS Report No 340 February 2021

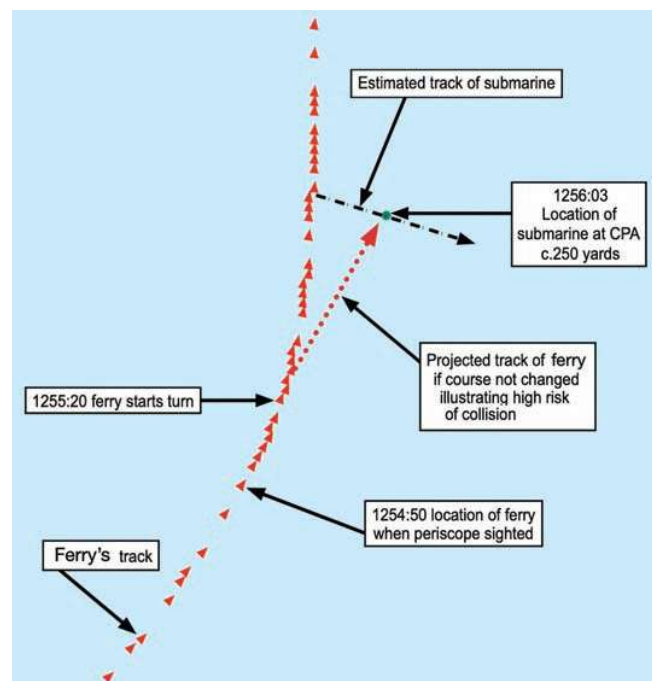
As it turned out, the submarine's command team had made several errors that each contributed to the close quarters situation. The approach speed of the ferry was under-estimated (taken as 15 knots instead of 21) and the ferry's range was overestimated. Both of these errors contributed to another critical error on the part the submarine's command team to remain at periscope depth instead of deep diving out of harm's way.

- This close call illustrates the importance of keeping a sharp lookout. Had the ferry's lookout not spotted the periscope, a high speed collision with the submarine was a distinct possibility.
- Turning to port to avoid a collision with another vessel on your port side is usually not the best choice of manoeuvres but given the speed of closure between the two vessels in this instance (27 kts), their respective positions and the good visibility, it proved to be the right one.

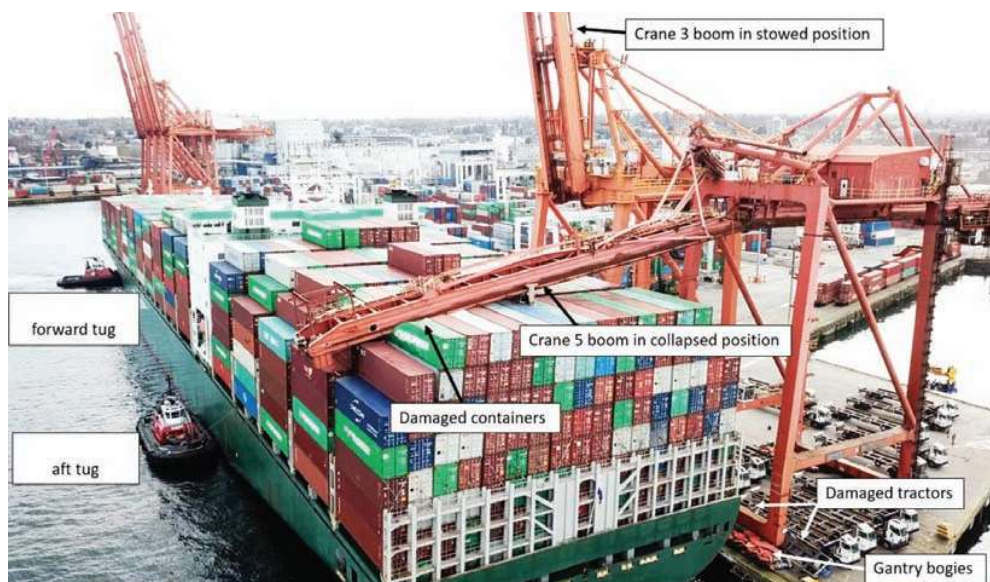
Although ultimately the collision was caused by human error, the investigation also found that there has been an increase in the size of container vessels berthing at the port over the last decade, and no corresponding upgrades to the terminal such as more appropriate fenders.

- If effective bridge resource management (BRM) is not maintained by bridge teams, including pilots and tug Masters, there is a risk that errors will go uncorrected and cause unwanted consequences.
- Some port infrastructure has not kept up with increases in vessel size and mariners should be aware of these inconsistencies.
