Mariners' Alerting and Reporting Scheme

MARS Report No 363 January 2023

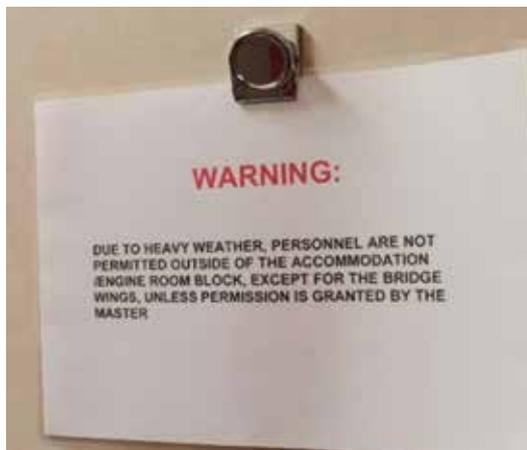
➔ A loaded VLCC was underway. The vessel's weather routing service was forecasting waves with a significant height of more than six metres. The vessel's speed was slowed to between five and six knots to reduce the chances of shipping seas on deck. Due to the heavy weather restrictions, access to the main deck was not permitted except when specifically permitted by the Master. This restriction was even posted on the central notice board.

One morning, a bilge alarm sounded for the bosun stores forward. The Master, on the bridge with the OOW, assessed the weather; they observed rough seas and a long and heavy swell. Sprays were being experienced on the starboard bow, but no seas came on deck. The deck on the port side bow remained dry. The ship's course was altered to give a better lee and the Master gave the Chief Officer and the Bosun permission to proceed forward via the safety walkway to check the bosun store bilges.

asked the Chief Officer to have a quick look at the anchor lashings before returning aft. A few minutes later, the Chief Officer reported that the port anchor lashing seemed to be loose; he informed the Master that he was going to tighten it.

The Bosun was seen lying on the walkway near the port anchor winch, but the Chief Officer was still not visible. The general alarm was sounded and an announcement was made. The vessel was slowed yet further and manoeuvred to have the waves astern, at which point a rescue team went forward. The rescue team found the Chief Officer and Bosun as indicated on the diagram and the victims were brought to the ship's hospital.

The investigation found that a wave, significantly higher than the observed waves, hit the vessel while the Chief Officer and the Bosun were at the bow. The investigation also found, among other things, that communication by portable satellite phone was not possible from the ship's hospital. Radio Medical Advice (RMA) was received by satellite phone on the bridge, but the hospital was five decks below. Immediate and critical medical treatment of the victims based on communications with RMA had to be relayed verbally from the bridge satellite phone to the caregiving personnel in the hospital either by internal phone, or in person. The report did not speculate on whether having communications directly to the ship's hospital would have made a difference in saving lives.

- Even when a wave pattern is coming from what appears to be one direction, it can combine with other wave patterns and occasionally create a wave that is significantly higher than the observed average.
- When observed average wave height is approximate to the vessel's freeboard, extreme caution should be taken when going on deck. An errant wave could sweep the deck with terrible consequences.
