Mariners' Alerting and Reporting Scheme

MARS Report No. 313 November 2018

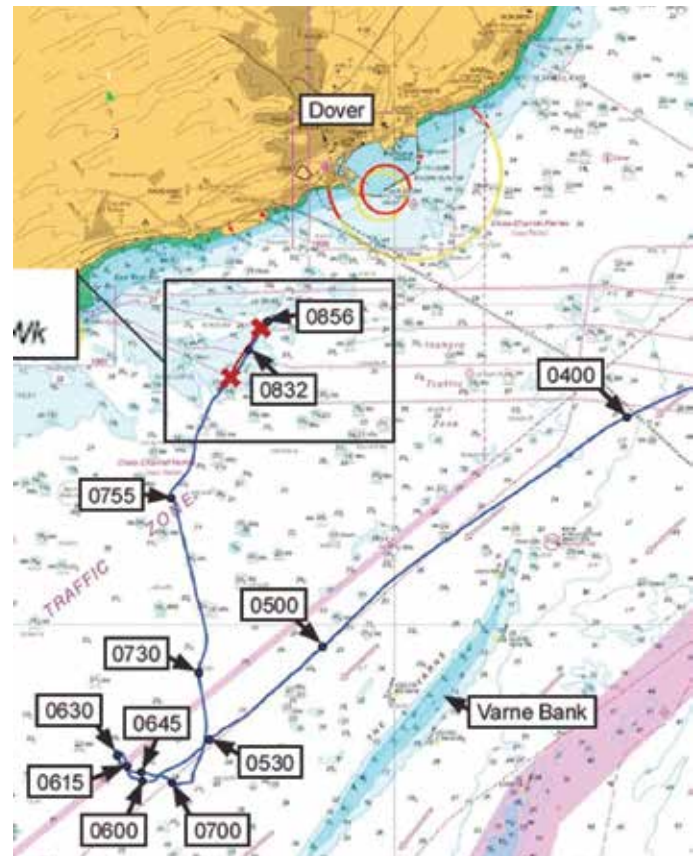
Finally, as the vessel drifted closer to shore and towards a rock barge that was anchored nearby, the vessel's crew deployed both anchors. By now the vessel had gathered considerable sideways speed and was drifting near 9kt, so the anchors did not hold. To add to the confusion the rock barge was also dragging anchor. Both vessels dragged their anchors over two subsea cables, which were severed as a result.

The general cargo vessel collided with the rock barge. At this point, the vessels remained locked together but stopped dragging anchor.

Collision damage with rock barge
