MARS – Lessons Learned

MARS Report No 365 March 2023

MARS 202311

Procedural shortcut undercuts quality

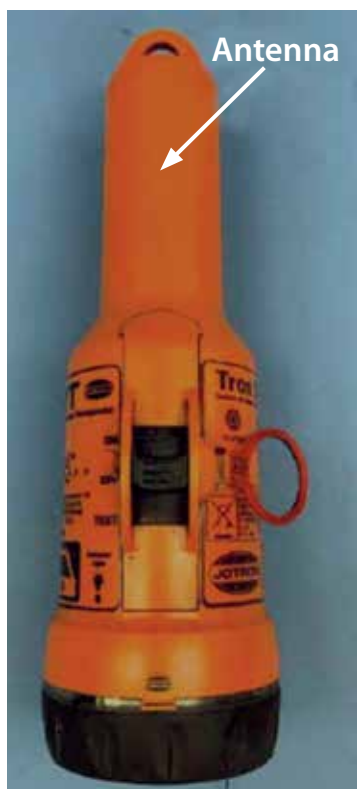
The narrow end of a SART is the antenna. This should be vertical and as high as possible. But the narrow end is also the only suitable location for a person in distress to firmly hold a SART. If a person in the water holds a SART by its antenna, the SART's ability to transmit and receive signals from an X-band radar will be reduced.

- If you are on a vessel that has been assigned search and rescue duties and are searching for possible survivors, do not use the AUTO mode for radar rain, sea and gain settings. Use the manual modes and adjust the rain and sea clutter settings to the lowest possible setting that will still give a somewhat clear screen. The gain should be put to the highest possible adjustment without causing undue radar returns that pollute the screen.
- If you are a survivor floating in the sea and have an activated SART in hand, hold it as high as possible above your head but do not use the narrow end as a handle. This is the antenna.
- If you are a survivor in a lifeboat or liferaft, mount the SART as high as possible with the narrow end up.
