MARS – Lessons Learned

MARS Report No 384 October 2024

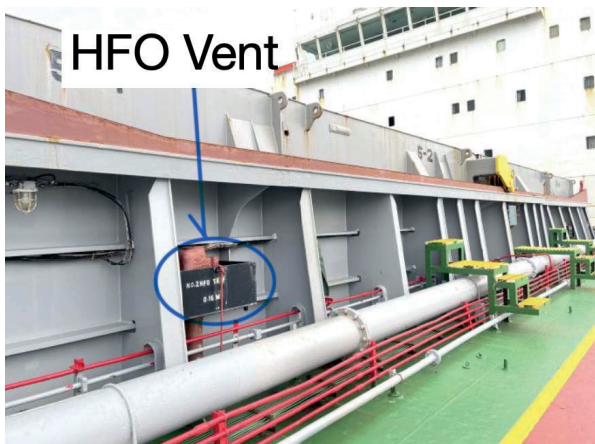
About 10 days after the cadet had been exposed to HFO vapours, the vessel was sailing in rough seas and several crew were seasick. Fearing that the cadet could be prone to falls in his weak state, the Master advised him not to leave his cabin and instructed another crew member to bring the cadet's meals to his cabin. Two days later, the Master communicated with the crewing manager informing him of the cadet's condition, which appeared to be worsening with dizziness, vomiting and diarrhoea.

It was agreed to divert to a port to allow medical attention for the cadet. Before the vessel could reach port, and some 13 days after having been exposed to HFO vapours, the cadet was found deceased in his bed. An autopsy determined the cause of death to be asphyxia due to aspiration of stomach content.

- Never be complacent about the medical care of a suffering crew member. If symptoms are prolonged or beyond the competencies of crew on board, seek radio medical advice directly from the Centro Internazionale Radio Medico (C.I.R.M.) or equivalent facilities.
- Be aware of skewed judgement calls. In this case the Master's sense of urgency may have been dulled by thoughts that the new cadet was suffering more from sea sickness and/or ship adaptation rather than gas poisoning.
