# RISK ALERT

## Work Safety - Adverse Weather

Written by  
**Nahush Paranjpye**  
Loss Prevention

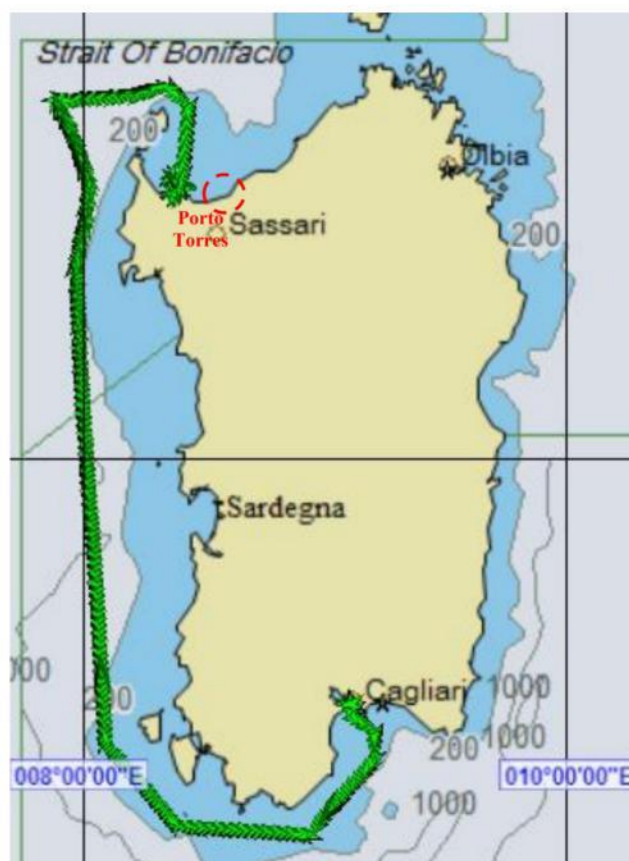
[Vessels Route - \(Ref: TMSI Report: 17/2020\)](#)

Vessel was experiencing North-westerly winds of Beaufort Force 8 and rough sea with a 5 m North-westerly swell. Air temperature 21 °C. Visibility 8nm.

Master altered the vessel's course to about 335°, with the intention of reducing the rolling motions. The bosun reported to the bridge that the trestles and landing gear of two trailers on the forward-starboard side were damaged and that consequently, these trailers had collapsed.

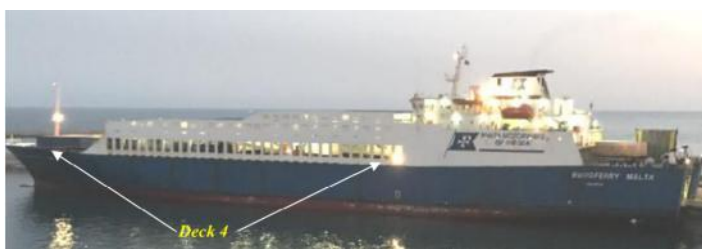
Deck 4 - (Ref: [TMSI Report: 17/2020](#))

While on the forecastle deck the bosun noted that the anchor lashings were loose (they were not secured in compliance with the company's procedures) and started walking back towards the ramp to call for assistance. At around this time a large wave washed over the vessels bow.

[Area \(Red circle\) where AB1 was found \(Ref: TMSI Report: 17/2020\)](#)

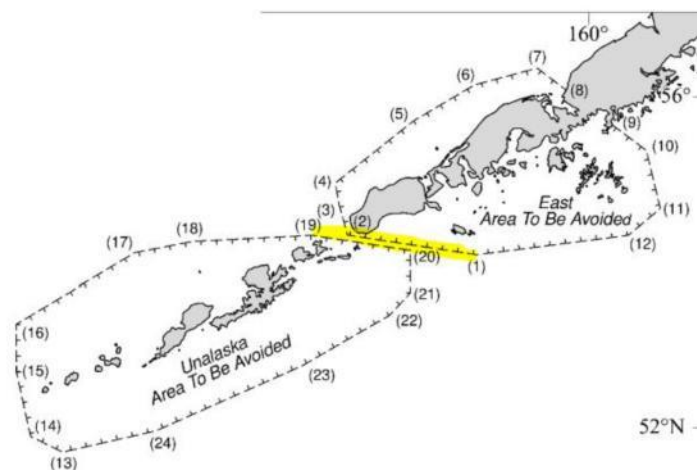
[Unimak Pass's safety fairway \(in yellow\) – \(Ref TMSI Report: 18/2019\)](#)

At 1225, as the vessel commenced her passage through the Unimak Pass, the second engineer (2/E), who was on duty, heard a very loud noise coming from the engine-room. Upon inspection, 2/E found that a spare auxiliary blower, amongst other items, had broken from its lashing and was moving freely on deck.

At 1235 following discussion, the master and several of the ships staff proceeded to the engine-room. It was discovered that the free, spare auxiliary blower had ruptured the stern-tube gravity tank, from where oil had spilled making the deck slippery. Furthermore, it was noticed that several items had also broken loose from their securing arrangements and were moving freely around the deck creating obstacles for the crew.

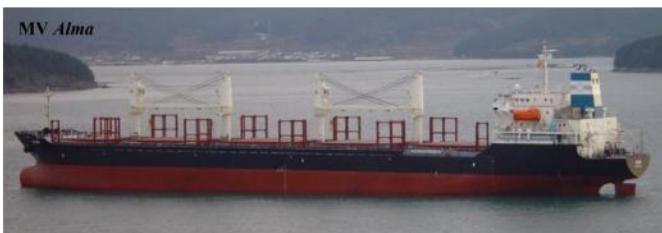
**MV Alma** (Ref: [TMSI Report: 22/2020](#))

Vessel was experiencing 25-knot winds from the North. Rough seas north-westerly swell of 3.5 m. Air and sea temperatures of 8 °C and 12 °C respectively. The vessel was rolling and pitching moderately.

At around 1953hours, on his way to the bridge, the third officer (3/O) met the electrical engineer (EE) in the stairway landing of deck 'A', wearing overalls and safety shoes. At about 1955 hours, the bosun, in his cabin on deck 'A', heard a sound from the accommodation stairway. On checking, he found the EE on his back at the bottom of the stairway.
