# RISK ALERT

## Work Safety - Adverse Weather

Written by  
Nahush Paranjpye  
Loss Prevention

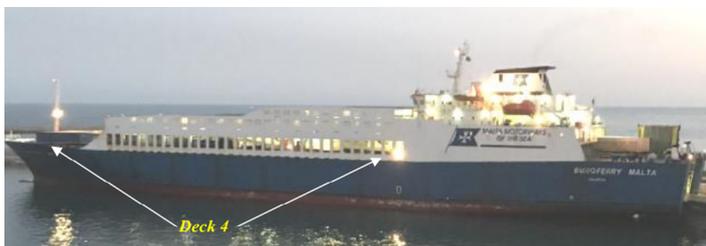
Deck 4 - (Ref: [TMSI Report: 17/2020](#))

While on the forecastle deck the bosun noted that the anchor lashings were loose (they were not secured in compliance with the company's procedures) and started walking back towards the ramp to call for assistance. At around this time a large wave washed over the vessels bow.

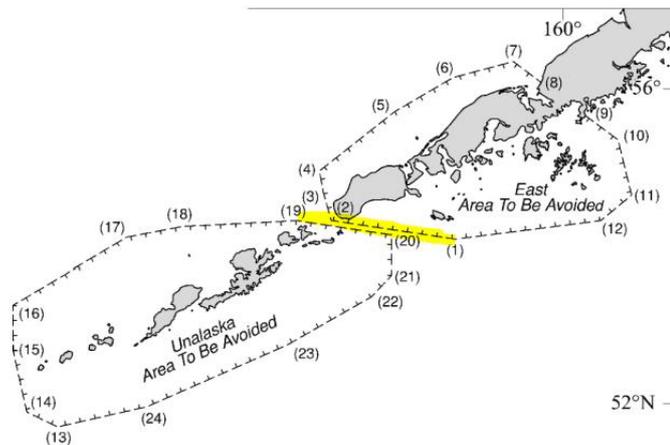
Unimak Pass's safety fairway (in yellow) – (Ref [TMSI Report: 18/2019](#))

At 1225, as the vessel commenced her passage through the Unimak Pass, the second engineer (2/E), who was on duty, heard a very loud noise coming from the engine-room. Upon inspection, 2/E found that a spare auxiliary blower, amongst other items, had broken from its lashing and was moving freely on deck.

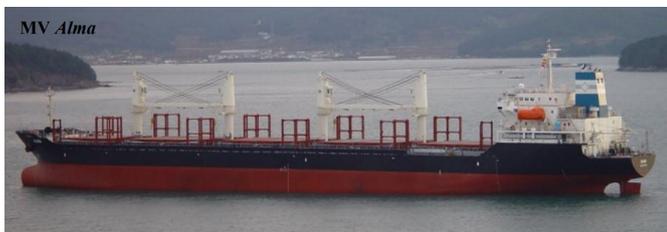
MV Alma (Ref: [TMSI Report: 22/2020](#))

Vessel was experiencing 25-knot winds from the North. Rough seas north-westerly swell of 3.5 m. Air and sea temperatures of 8 °C and 12 °C respectively. The vessel was rolling and pitching moderately.
